Siemens Surpresso Outlet Valve repair

Replace the gaskets in the outlet valve of a Siemens Surpresso

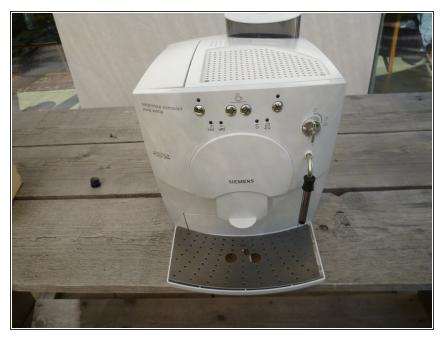
Step 1 — Opening the Siemens Surpresso Compact

- ↑ Unplug your coffee maker!
 - Remove the water container, the brew group and the drip tray with pomace container.
 - Using a spoon, remove as much of the coffee beans as possible from the coffee bean container.
- i Depending on the model, additional sensors with cables may be installed on the top and side panels. You have to remove these before you can completely remove the housing parts.

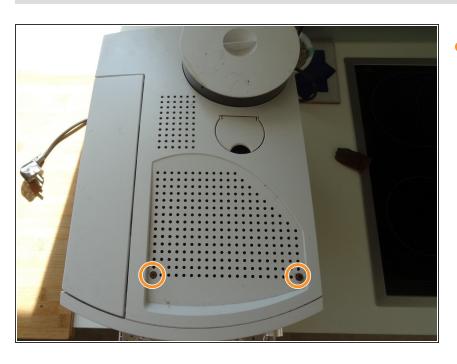
Step 2

Remove the two Torx T10 screws on the top.

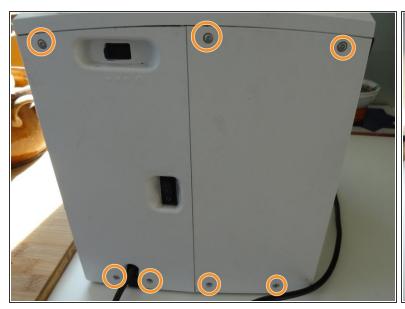
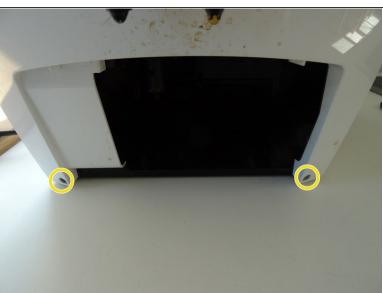
- Remove seven T10 Torx screws on the back.
- The two screws at the bottom of the front can remain.

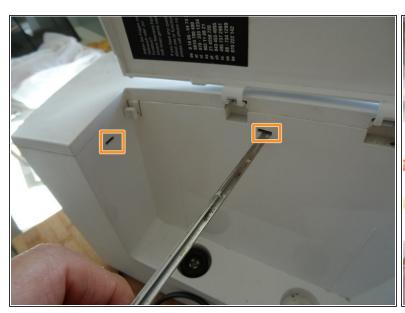
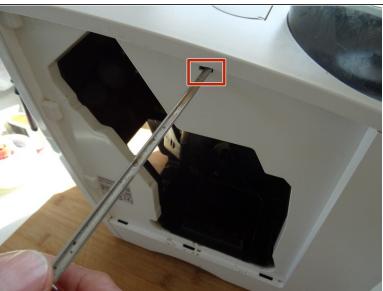
- Press with a flat-head screwdriver into the openings on the side with the water tank. This releases the latches on the top.
- Press the flat-head screwdriver into the opening on the side with the brew group. This will release the last notch on the top.
- Lift the top off.
- On some models, a cable leads to the sensor on the powder tray. Unplug the connector on this
 cable first.

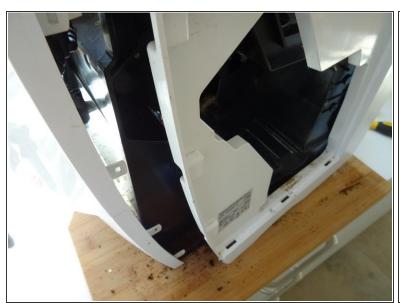
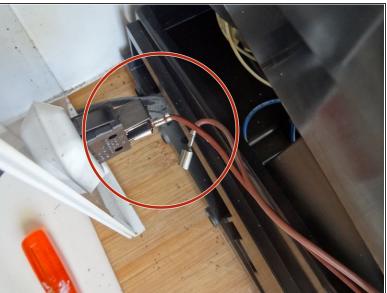
Step 5

- Slide the side section of the brewing unit about 2 cm to the rear. This sometimes gets stuck and may require some force to remove.
- Remove the two tabs from the power switch.
- Take off the side panel with the brew group.

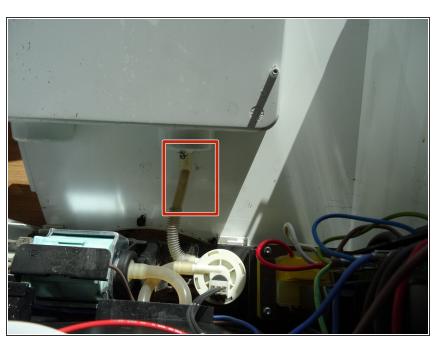
- Do the same with the panel on the other side.
- To remove the water tank hose simply pull it of the pump.
- Remove the side panel.

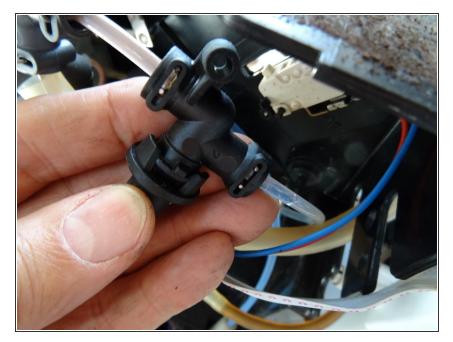
Step 7 — Outlet valve

Look for the outlet valve on the top right of the device.

- There are three latches securing the valve lid. Carefully lift the lid up using a metal spudger.
- Lifting the lid exposes a spring, a plunger and its holder, an O-ring and the seal of the plunger. The photo shows clearly the imprint of the valve seat, so the valve doesn't close properly. The plunger tends to break but the spare plunger in the repair kit is made of metal.
- (i) Note the order and orientation of the parts (photo).
- (i) Alternatively you can replace the complete valve, it's not too expensive.
