# Water connection seal replacement

Replacement of the water connection seal on a Saeco Vienna Sup018

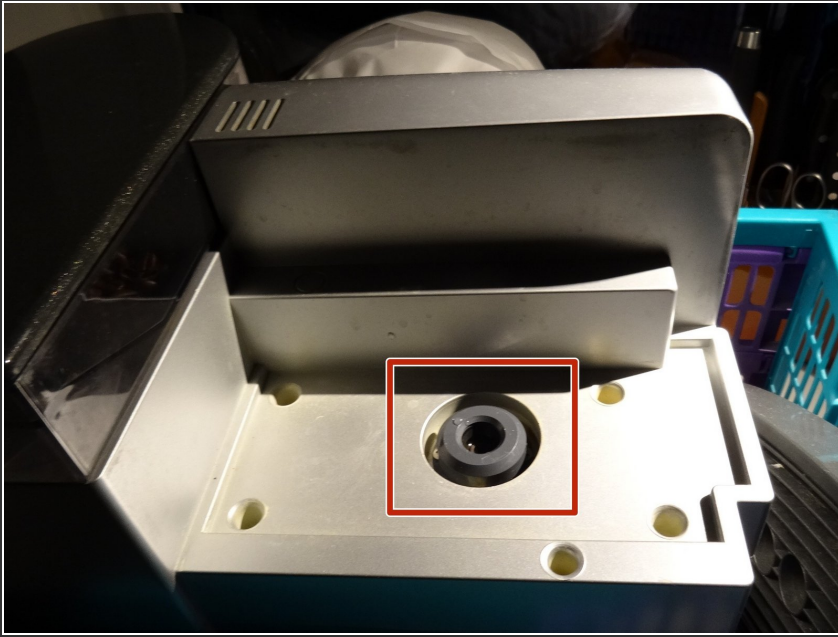
## Step 1 — Water connection seal

- Take the water tank off.
- The seal is held in place only by a cover.
