Pebble Time Steel - reparing of a non working button

A non working button that lost its gum is made reusible with some drops of superglue.

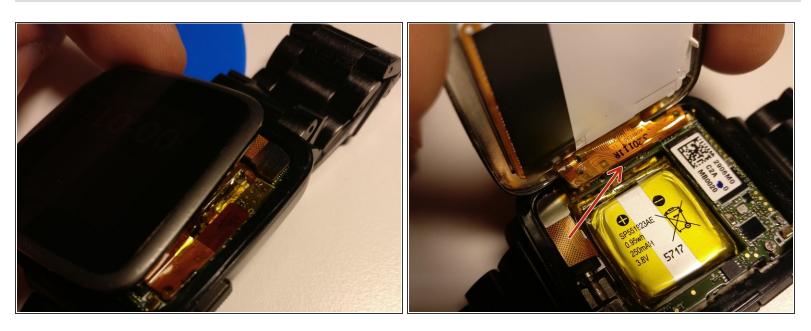
Step 1 — Repairing of a non working button

With opening picks we start to open the watch by lifting up the display bottom from left (about seven o'clock) in counterclockwise direction. In the left side there is a flexband that has to be disconnected.

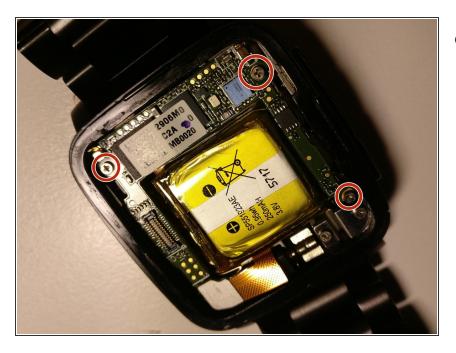
Step 2

Three screws are removed.

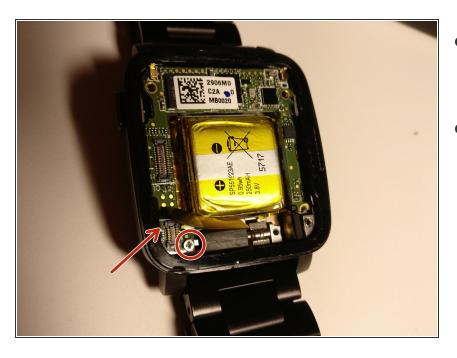
Step 3

- down on the left, a Flexband is carefully folded up and loosened.
 Below it, another screw is visible.
- Remove this screw.

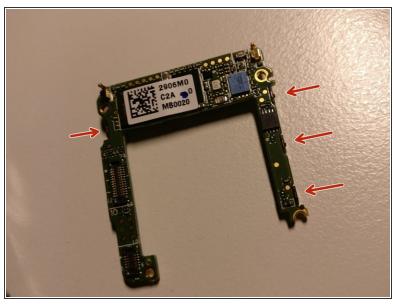
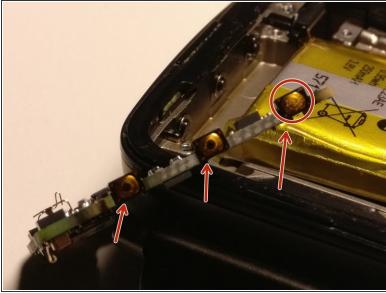
Step 4

- Then the board can be removed carefully.
- If you look closely at the keys, you can see that the defective key no longer carries rubber dabs.
- With a needle, the smallest drops of superglue are dripped into place of the missing rubber.
