Motorola Moto G7 Play Charging Port Replacement

When the Motorola G7 Play, models XT1952-3 and XT1952-2, no longer charges, it could be due to a failing charging port. This replacement guide provides efficient steps to get the device working again. If replacing the charging port doesn't fix the issue, attempt to replace the battery with this [guide](#).

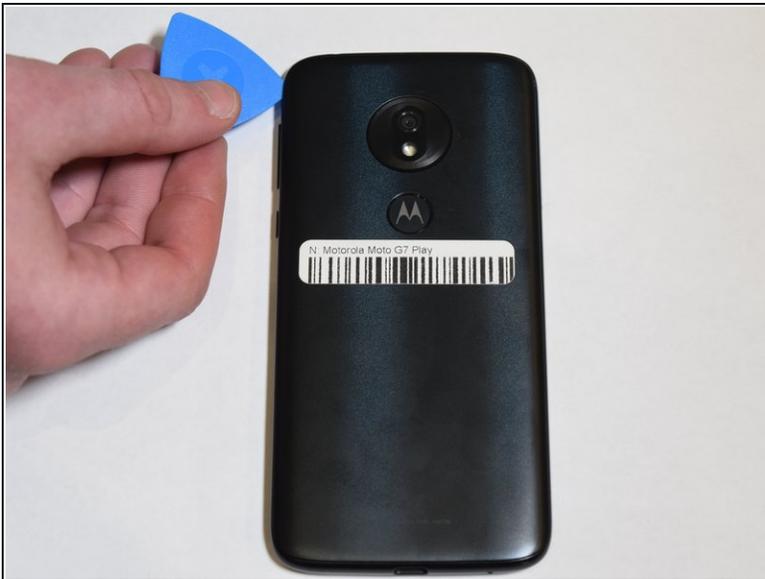
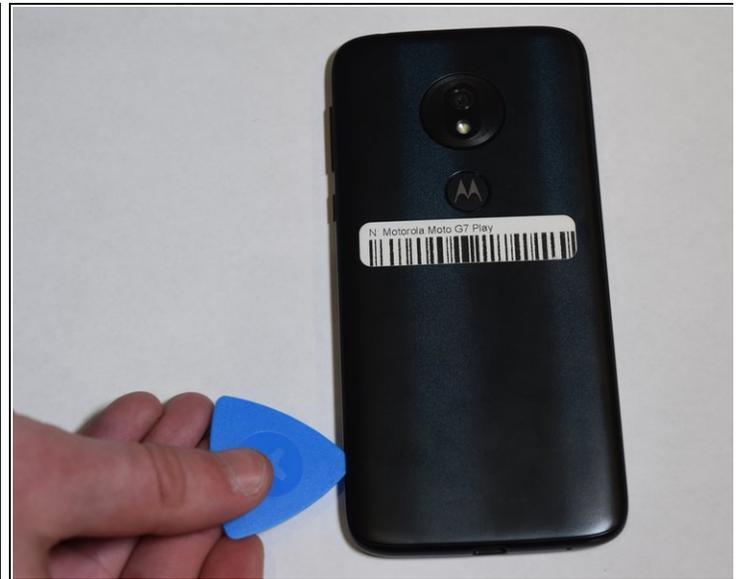
Step 1 — Back Cover

- Use the iFixit pick to break the adhesive around the back case.
-

Use a heat gun, hairdryer, or iOpener to weaken the adhesive around the back case. If you're using the iOpener, please review the [instructions](#) for proper use.

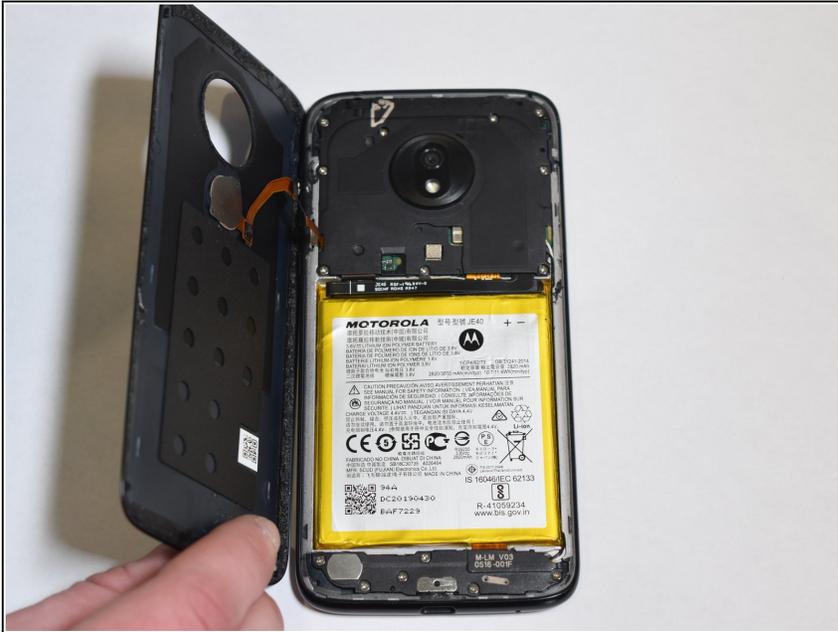
Step 2

- Detach the back case from the phone.

⚠ Make sure the back is opened right to left so the cable of the fingerprint scanner does not get damaged.

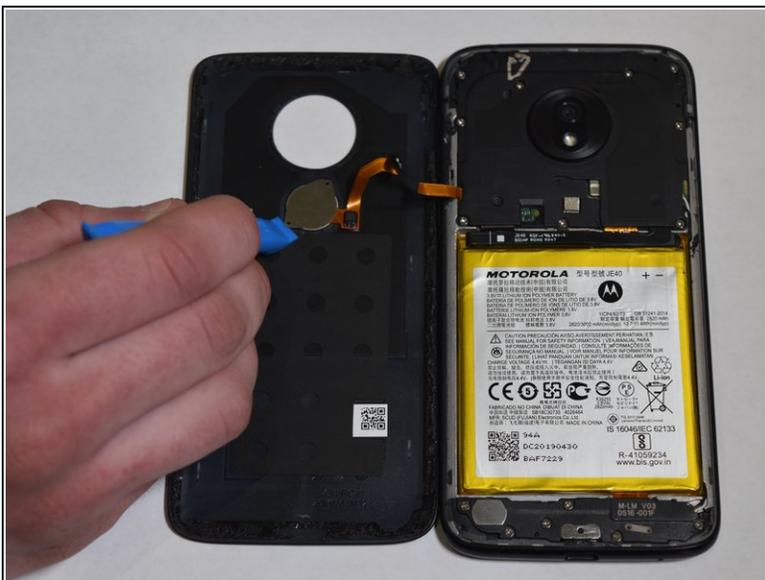
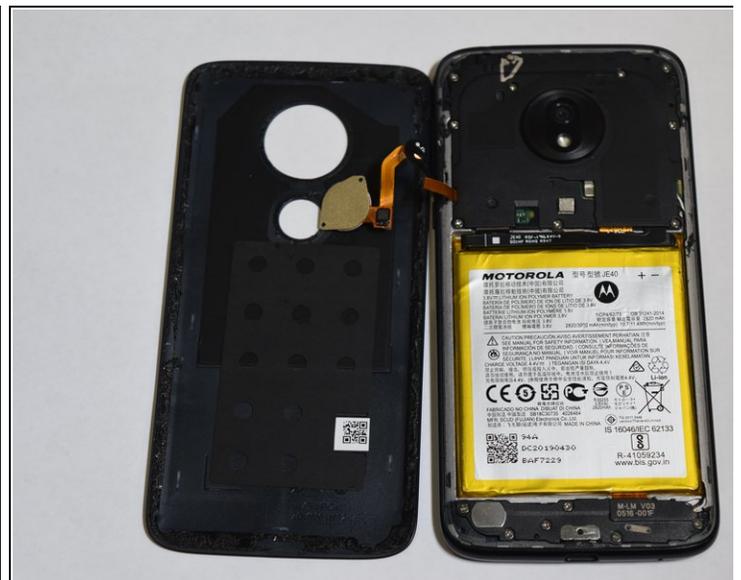
Step 3

- Use the iFixit pick and the iFixit opening tool to pull the fingerprint scanner off of the back case.

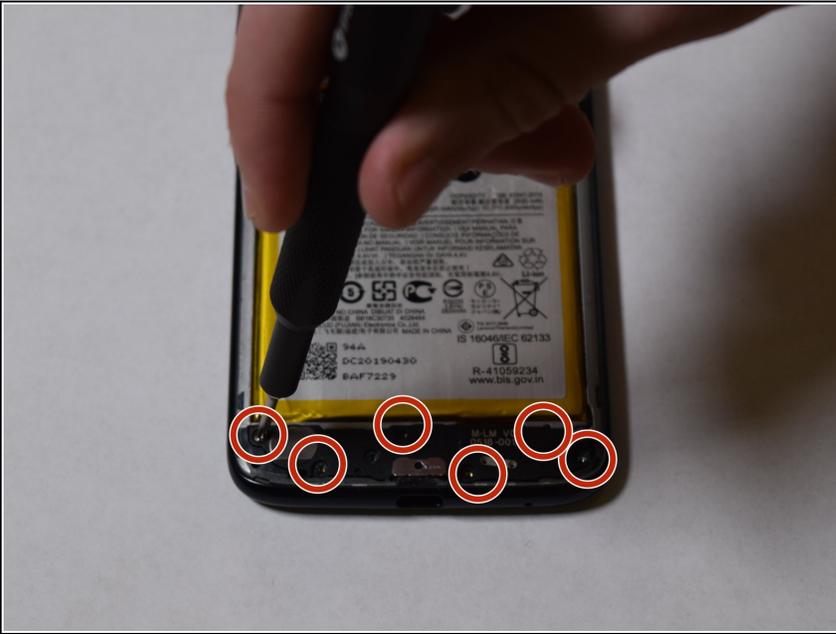
Step 4 — Charging Port

- Remove the six 3.2 mm screws from the charging port assembly cover with a Phillips #00 screwdriver.

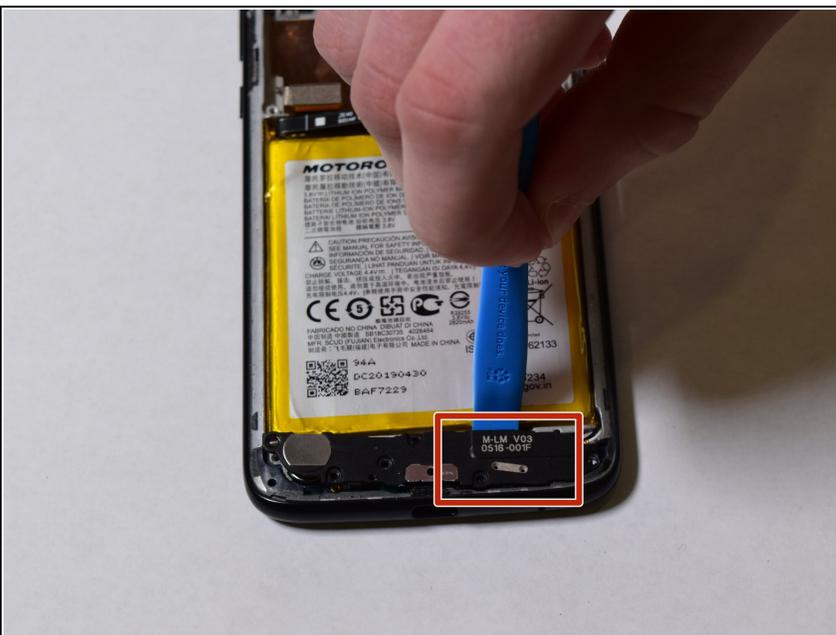
Step 5

- Using the iFixit opening tool, carefully pry up the charging port assembly cover.

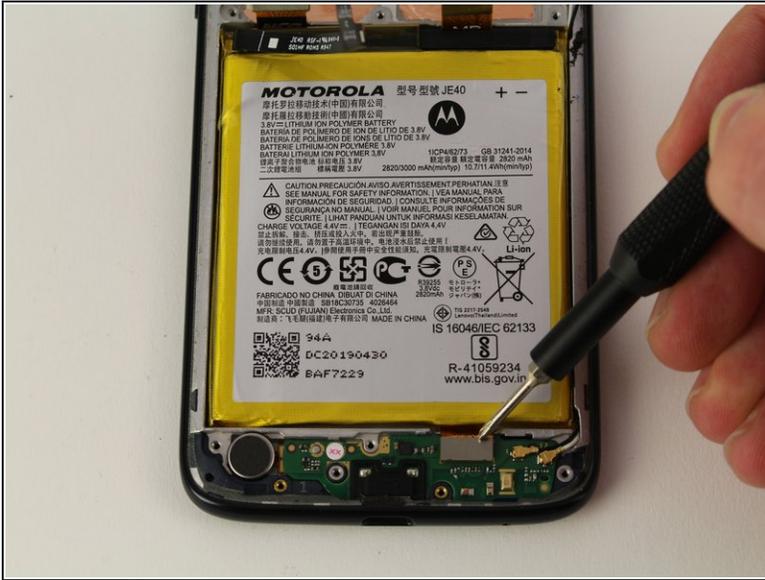
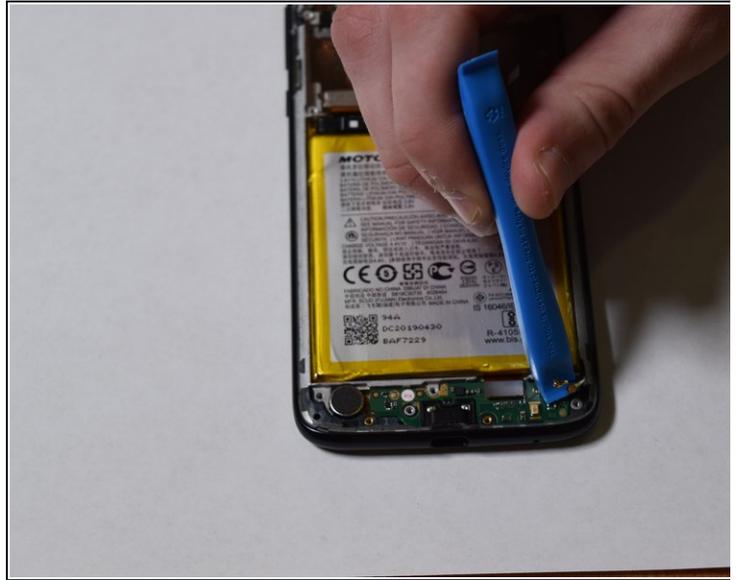
Step 6

- Using an iFixit opening tool, detach the cables from the charging port assembly.

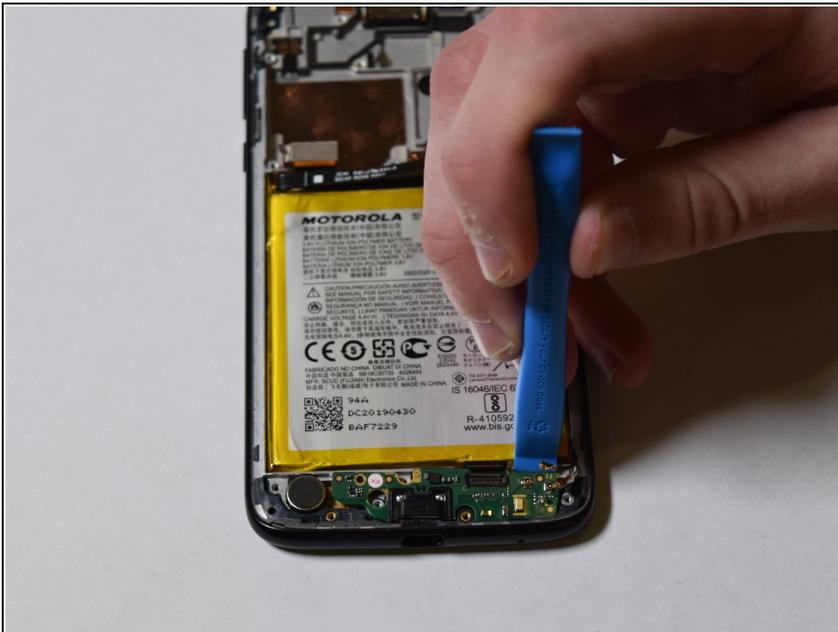
Step 7

- Using the iFixit opening tool, carefully pry up the charging port assembly.
