1998-2003 Mazda Protégé Radio LCD Screen Repair.

How to fix or repair a broken / ghosted / blinking / inconsistent LCD display on a 2001 Mazda Protege radio.

Written By: Shmuel Ament

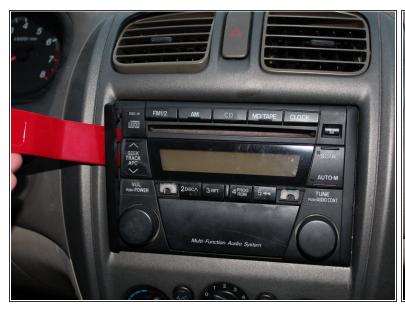
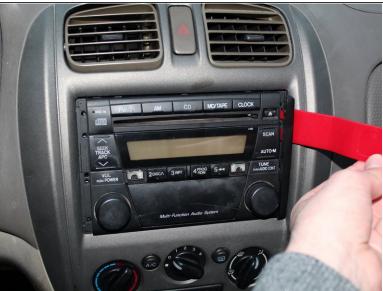
Step 1 — 1998-2003 Mazda Protégé Radio LCD Screen Repair.

Use the spudger to remove both side covers to access the radio removal holes.

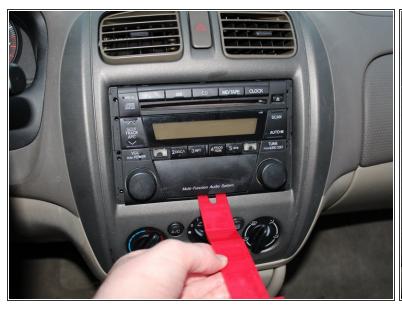
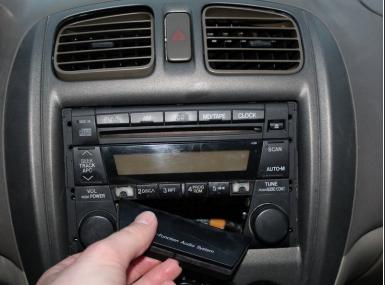
Step 2

Use the spudger to remove this plastic cover to make the radio removal easier.

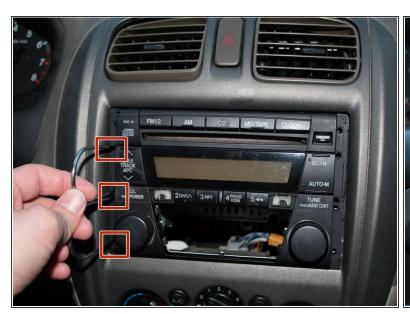
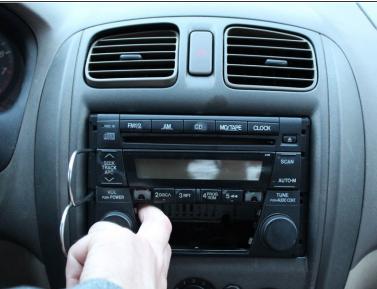
- Remove each side of the radio separately. Starting with the left side, put the 'radio removal tool' in the bottom 4 holes until you hear a "click"
- (i) The top hole is not for the radio removal tool.
- Then pull the left side of the radio out.
- it may be easier if 2 sets of radio removal tools are used (2 come in one set). Then both sides can be removed at the same time.

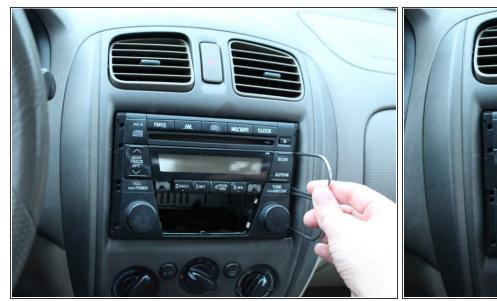
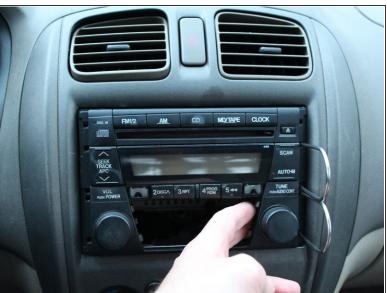
Then repeat the process with the right side.

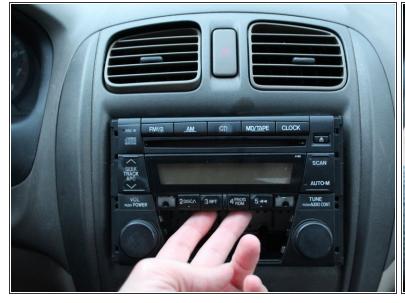
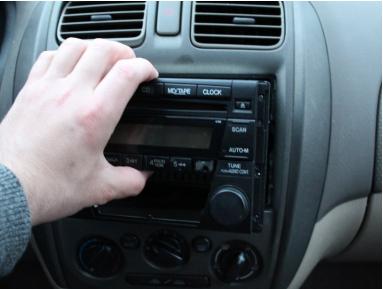
Step 5

Pull the radio out, you may have to wiggle it back-and-forth several times to get it out.

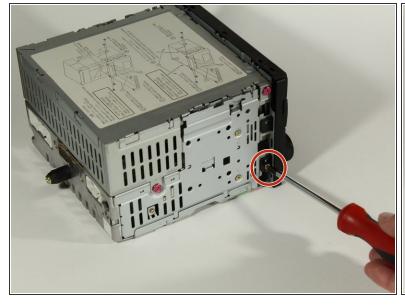
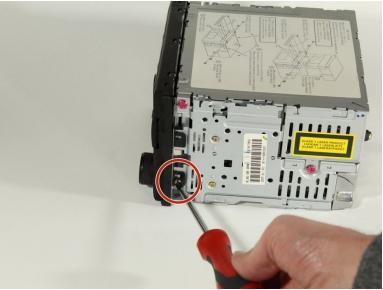
Step 7

Using the Phillips #2 screwdriver, remove the two 5.0 mm screws on either side of the control panel.

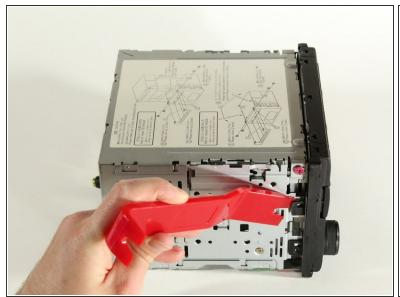
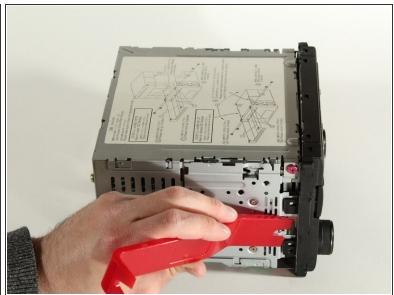
Pry-off the control panel tabs with the spudger.

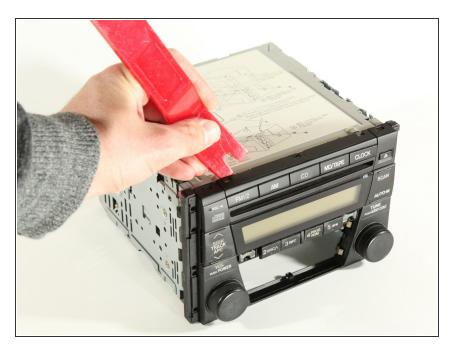
Step 9

Using the spudger, pry the top control panel tabs off.

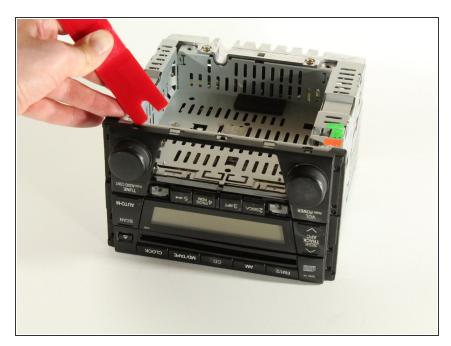
Using the spudger, pry the bottom control panel tabs off.

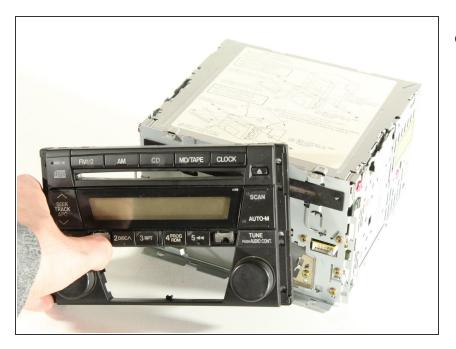
Step 11

Remove the control panel.

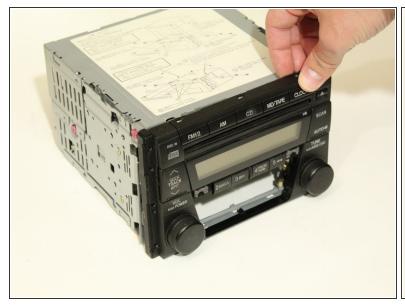
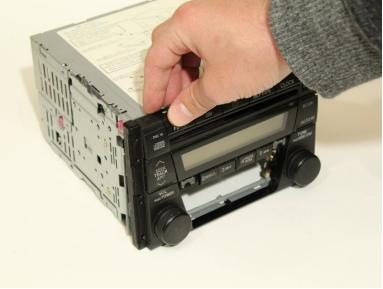
Step 13

Re-clip the control panel back onto the radio.

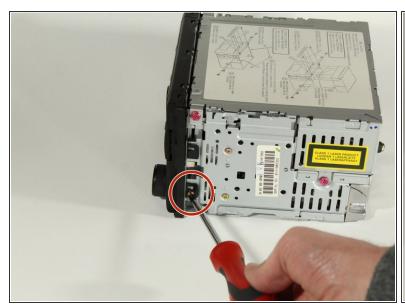
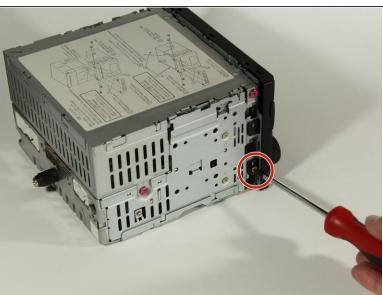
Using a Phillips #2 screwdriver, screw in both 5 mm screws on either side of the radio.

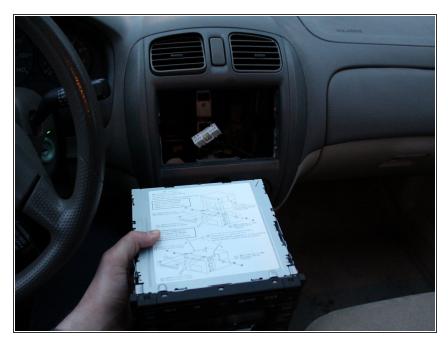
Step 15

Insert the radio back into it's place in the same way that you removed it.
