# Siemens EQ5 Brew group revision

Written By: VauWeh

The brew group of these machines can be easily removed for cleaning. The most important seals need to be replaced from time to time. This is shown here.

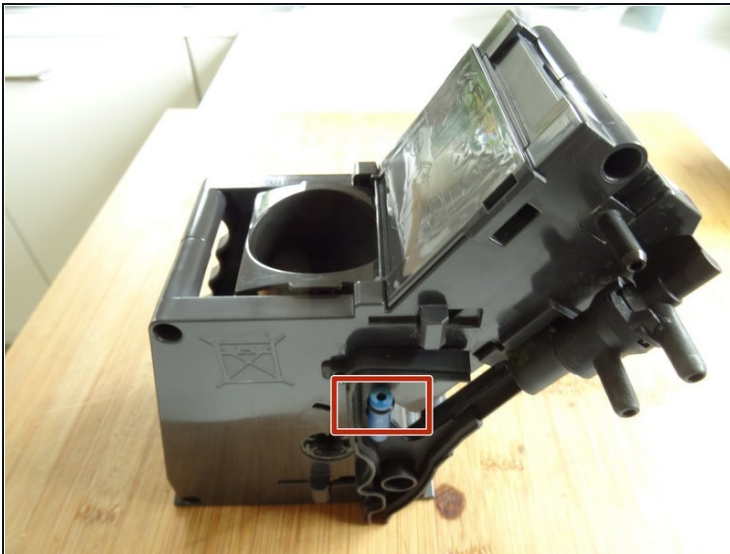
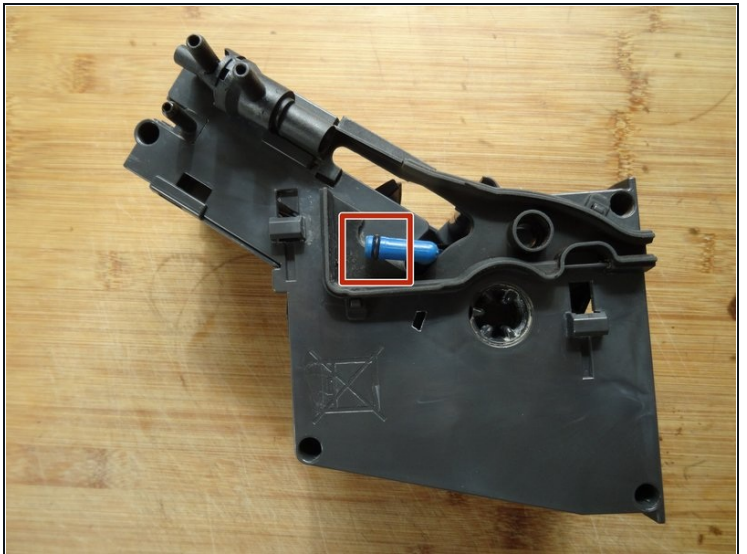
### Step 1 — EQ5 Brew group revision

- Picture of the brewing unit. The first gasket to be replaced is on the blue water inlet.
  - ① This seal can be replaced immediately without further disassembly. The gasket is under strain and should be replaced quite often. It slides better when thinly coated with food-grade silicone grease.

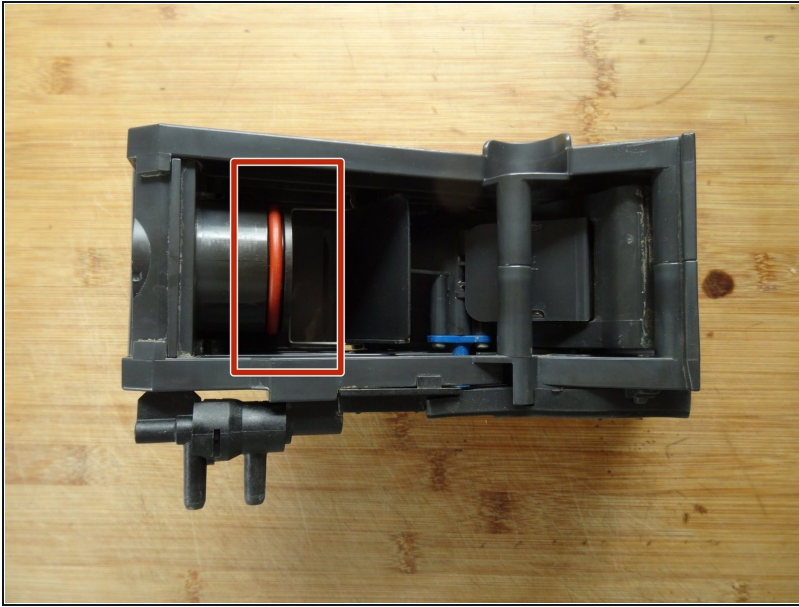
## Step 2

- The second seal, which should be replaced more often, is located on the upper piston. In theory, it could also be replaced without further disassembly. Since opening the brewing unit is not difficult, it can be cleaned more thoroughly.

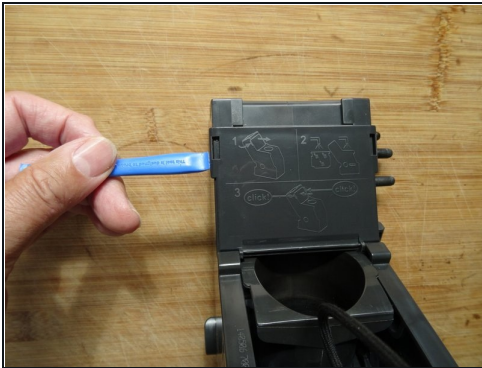
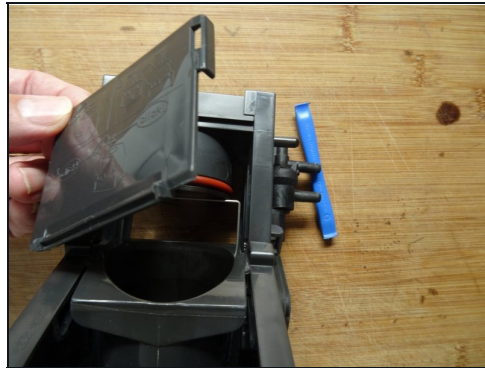
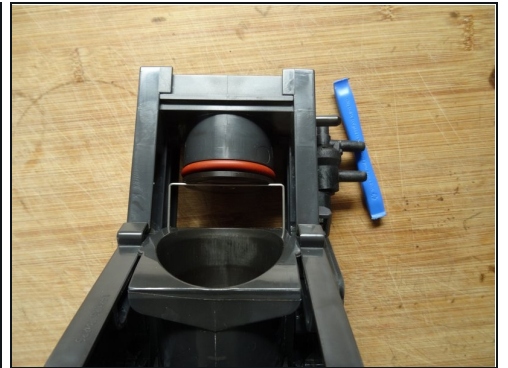
## Step 3

- Remove the cover from the upper piston. Reach under the notches on the left and right, a plastic tool is helpful here, but you can also use your fingers. Remove the cover.
- Now the upper piston is easily accessible from two sides and can be cleaned quite well.

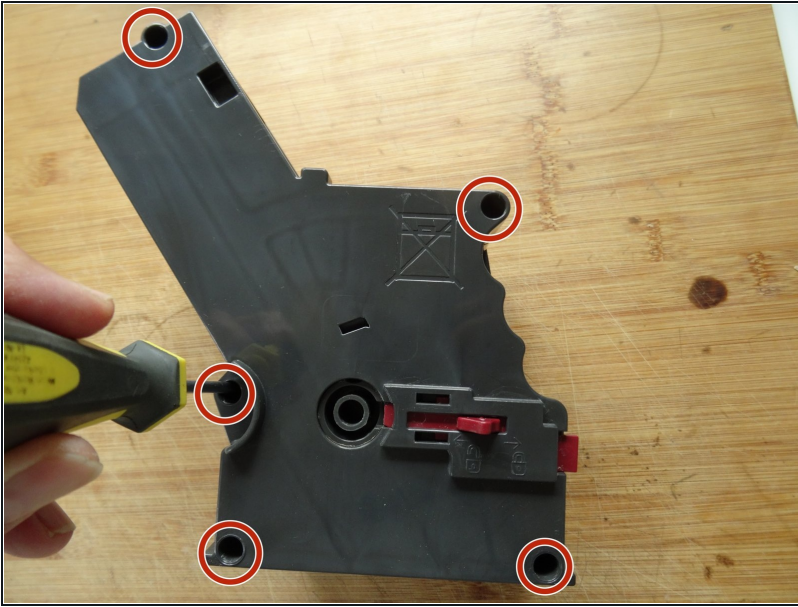
## Step 4

- Place the brewing unit on the work surface as shown.
- Unscrew the **five** Torx T10 screws.

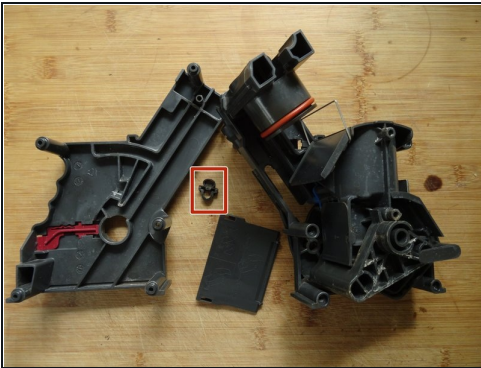
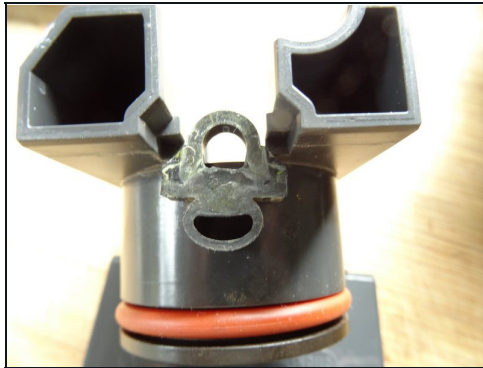
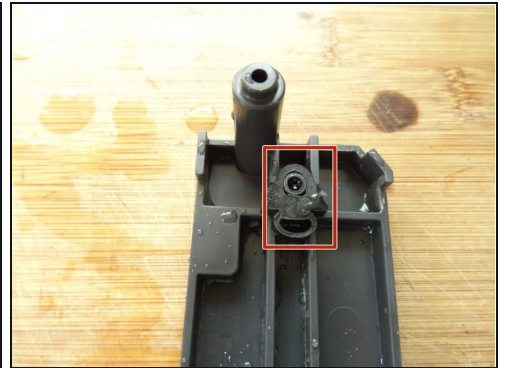
## Step 5

- Lift the upper side plate. The rubber bumper at the top of the piston will probably fall off. It must be pushed back into the top of the pin on the side plate during reassembly, with the smaller bumper facing down.

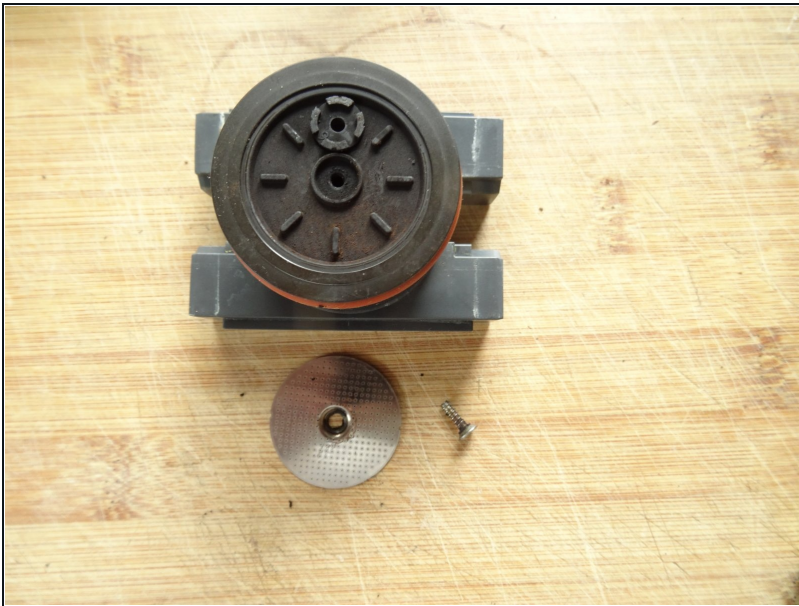
## Step 6

- Pull out the piston completely.
- Unscrew the Torx T10 screw on the brewing filter.
- Take off the brewing filter.

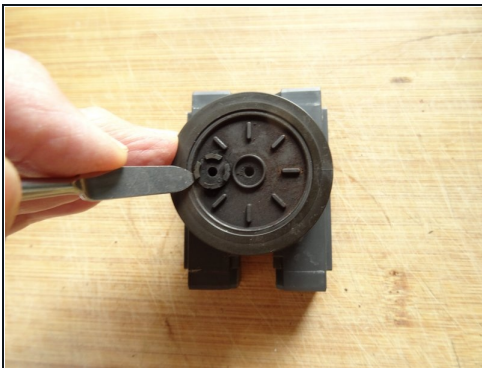
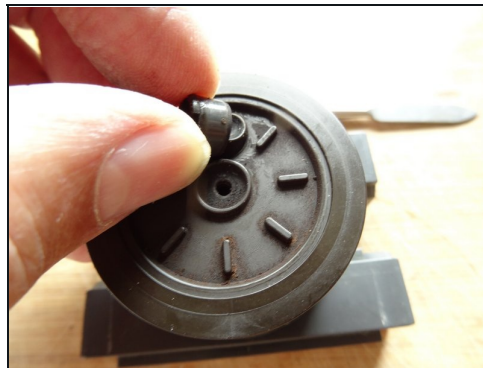
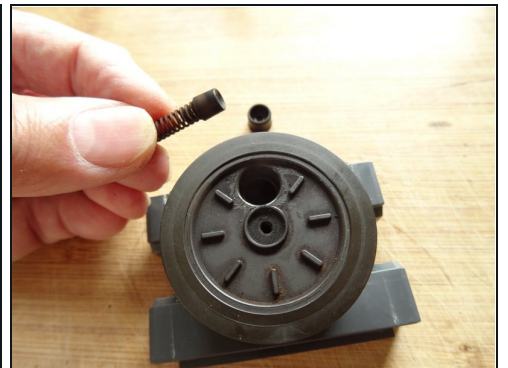
## Step 7

- Using a blunt tool, lift out the lid above the crema valve. Lift off the lid.
  - ① The lid is stuck very tightly. Pry it up all around with the tool to lift it up gradually.
- Pull out the crema valve.
