# **Garmin Nuvi 370 Microphone Replacement**

In this guide the repairer replaces the microphone by disassembling the device to access the motherboard.

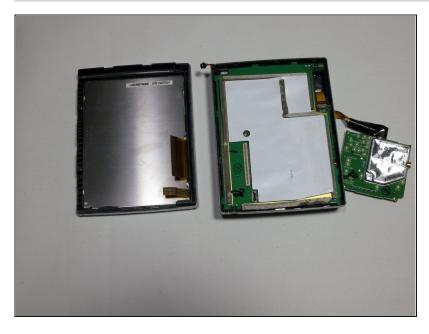
### Step 1 — Microphone

After following the instructions in the main dis-assembly guide, you should have the screen detached from the motherboard.

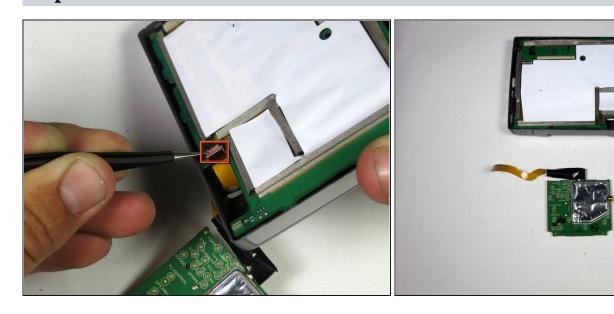
### Step 2

• Use the <u>tweezers</u> or the spudger to lift the tan latch off the ribbon cable (ZIF connector) and gently pull out the ZIF connector and cable from underneath the opened latch.

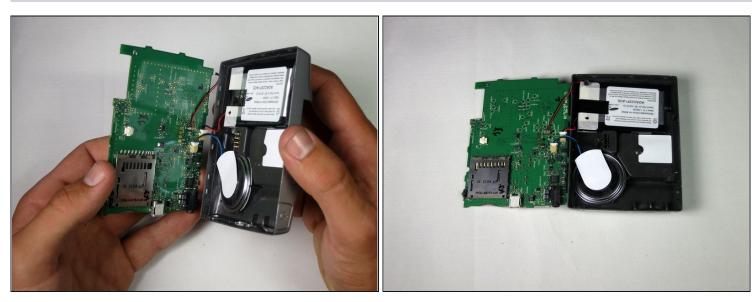
### Step 3

• The motherboard will now freely separate from the back casing; lay it flat next to the housing.

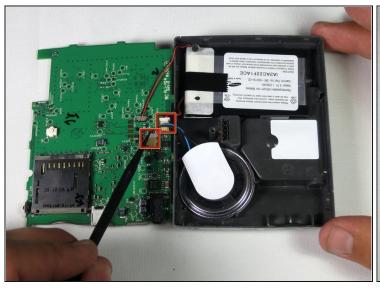
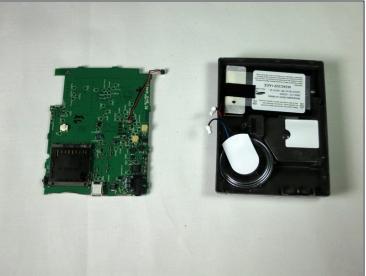
#### Step 4

- Disconnect the speaker and battery from their terminals on the motherboard. This should disconnect the motherboard completely from the back panel.
- ① This step is optional but is recommended as it will create more room to work.
- It is recommended that you use tweezers or the spudger for precision.

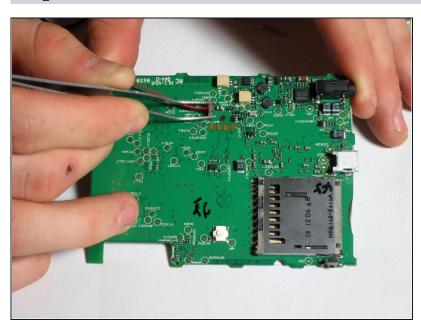
### Step 5

Gently pull out the microphone wire from the terminal.
Tweezers are recommended for precision.

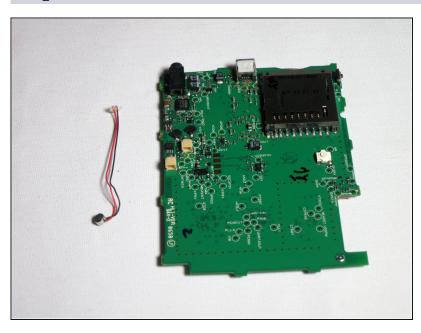
## Step 6

- The microphone component should now be completely separated from the motherboard.
- Plug in new, functional microphone component.
