# PlayStation VR Band Adjuster Replacement

Written By: Aaron Suttles

Over long periods of time and use, the manual adjustment wheel for the PlayStation VR headset can wear and the teeth can dull. This guide will assist with replacing the mechanical adjustment wheel for the PlayStation VR headset using basic household tools. While this project doesn't require a lot of tools, it does require a delicate touch when working with the headband and plastic tabs. If you are too rough with these parts they can become damaged and will require more maintenance.

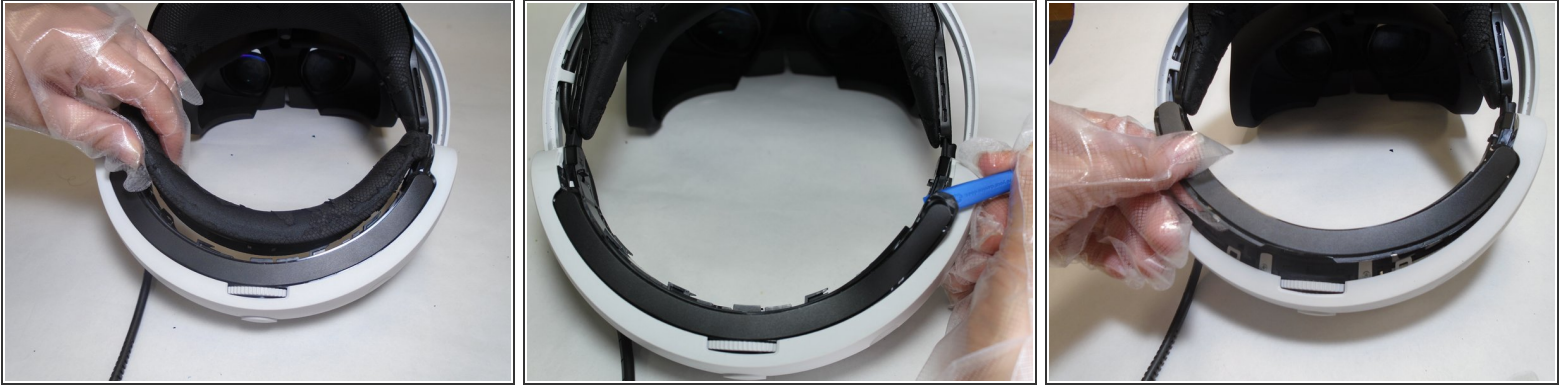
## Step 1 — Band Adjuster

- Use your hands to remove the foam piece in the headband.
- Use the iFixit Opening Tool to pry the top and bottom trim pieces off of the rear band assembly.

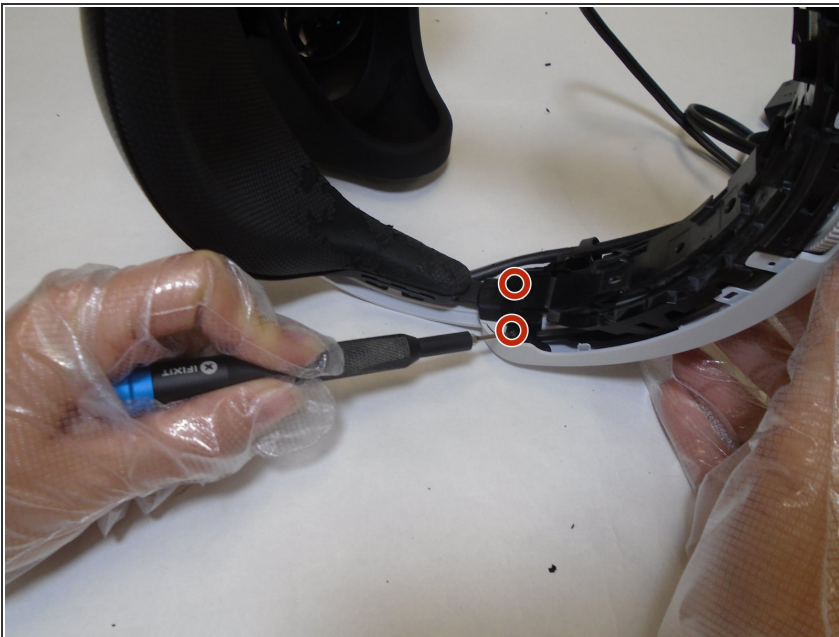
## Step 2

- Remove a total of four 5 mm screws from inside the left and right sides of the headband using a Phillips #00 screwdriver.

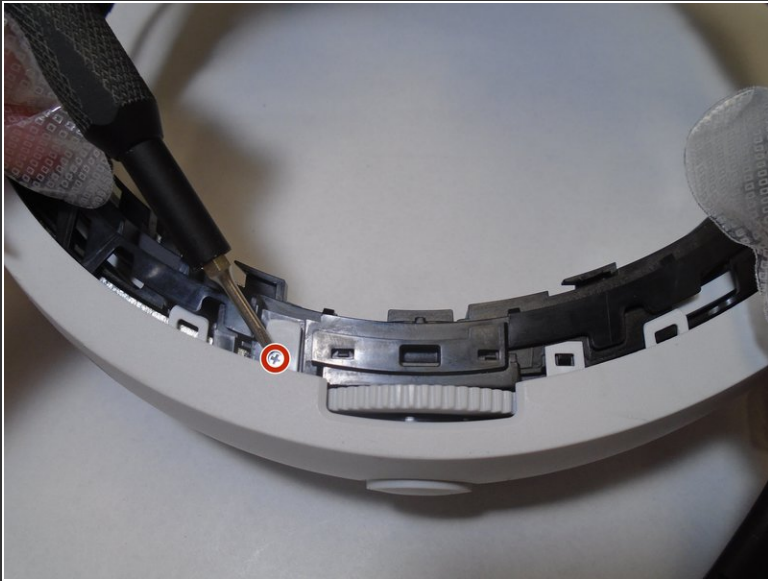
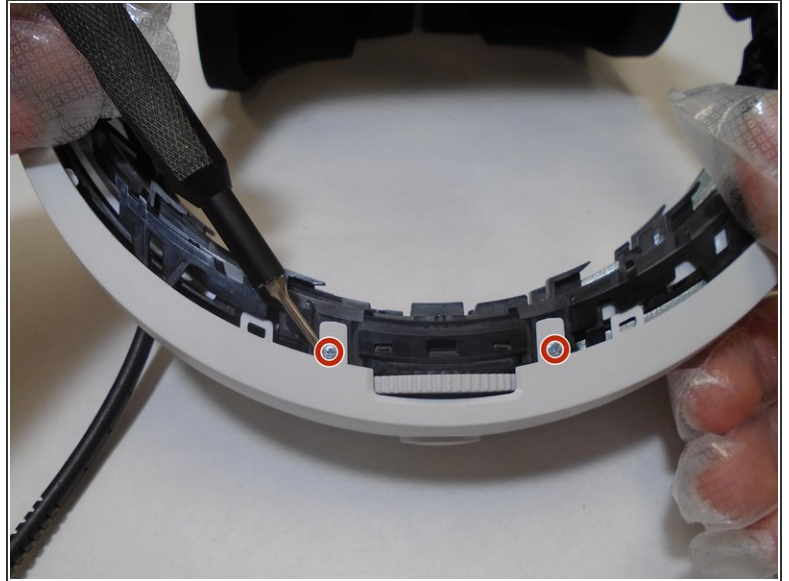
### Step 3

- Remove three silver 5 mm screws that are securing the rear white cover of the band using a Phillips #00 screwdriver.

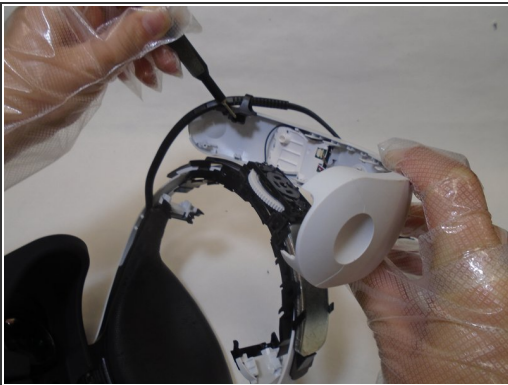
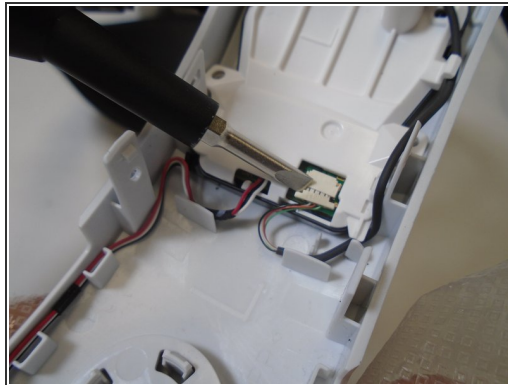
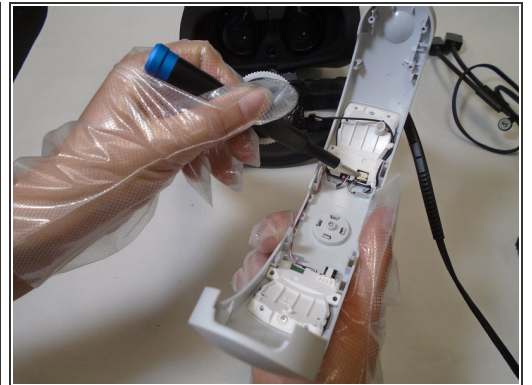
### Step 4

- Remove the 6 mm screw from the retainer securing wires to the rear band assembly using a Phillips #00 screwdriver.
- Use a spudger to flip up the retaining flap connected to the rear LEDs.

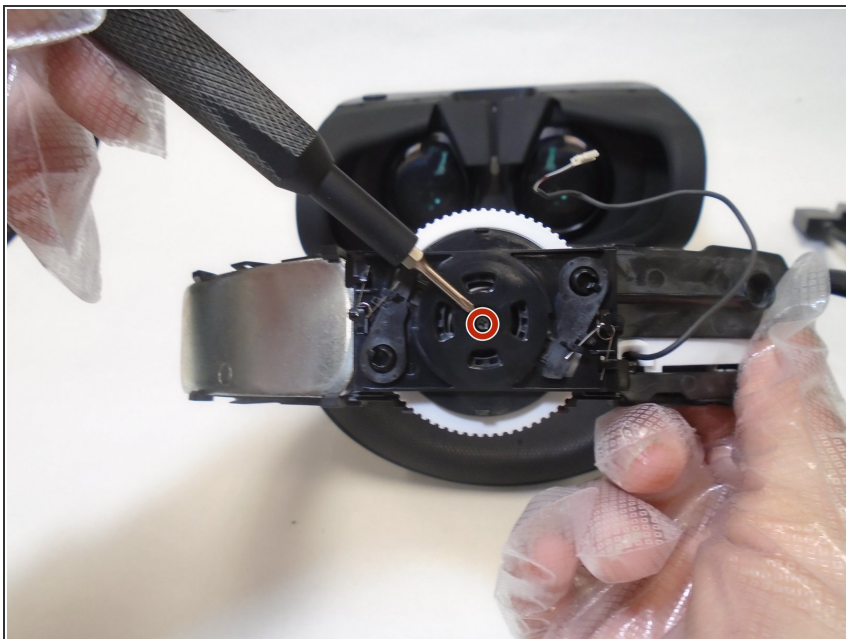
## Step 5

- Remove the single 5 mm screw from the center of the headband adjuster using a Phillips #00 screwdriver.

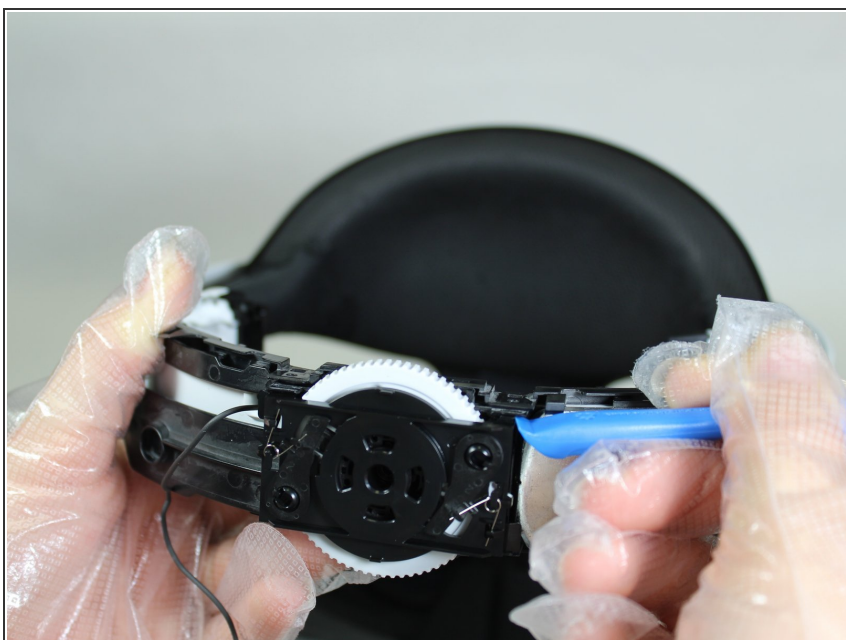
## Step 6

- Gently pry the adjuster assembly away from the rear headband using an opening tool.

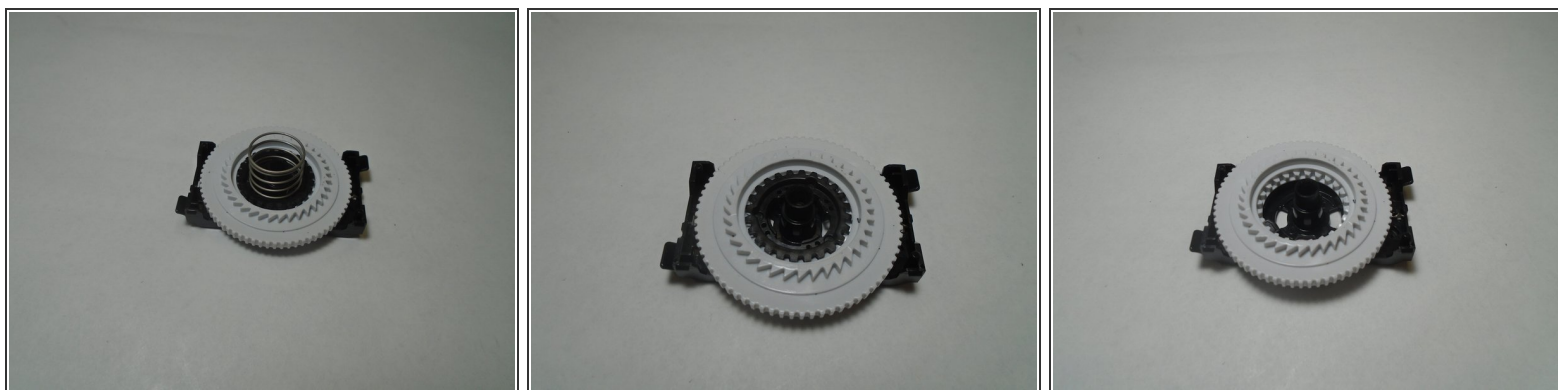
## Step 7

- Disassemble the adjuster assembly spring, small gear, large gear, and bracket in order to replace the broken component.

To reassemble your device, follow these instructions in reverse order.
