Xbox One Teardown

Xbox One teardown on November 21, 2013.

Written By: Sam Goldheart

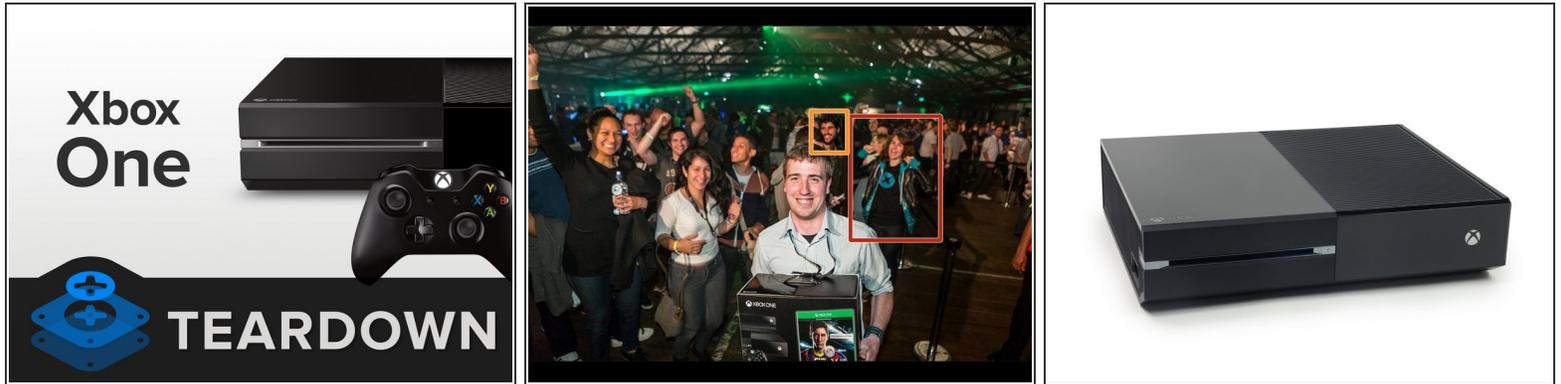
Step 1 — Xbox One Teardown

- This is the One. The One we've all been waiting for this whole time. The Xbox One.
- Think we're pulling your leg with all this New Zealand funnybusiness? Check out the folks in the background of [this Xbox New Zealand release photo](#)—that would be our very own [Samantha Lionheart](#) (in red) and [Optimus Goldberg](#) (in orange).
- Tech Specs:
 - 8-core x86 processor
 - HDMI pass-through
 - 8 GB of RAM
 - 500 GB storage capacity
 - Blu-ray/DVD drive

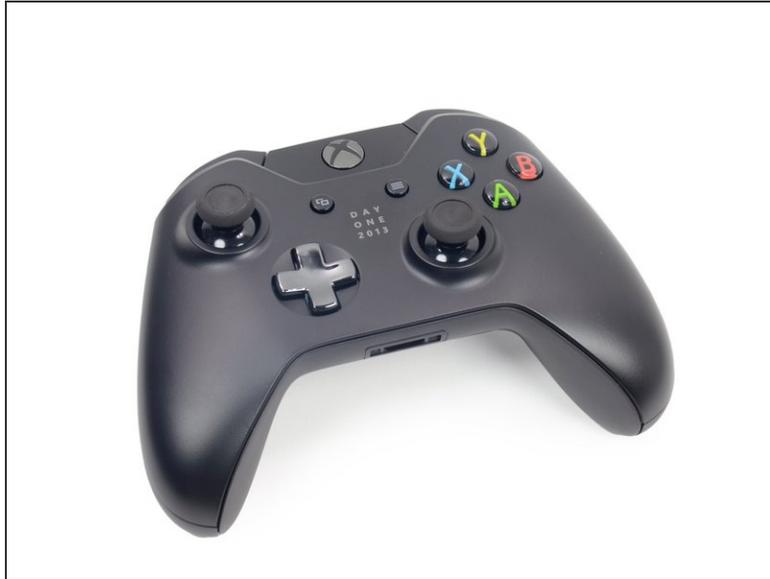
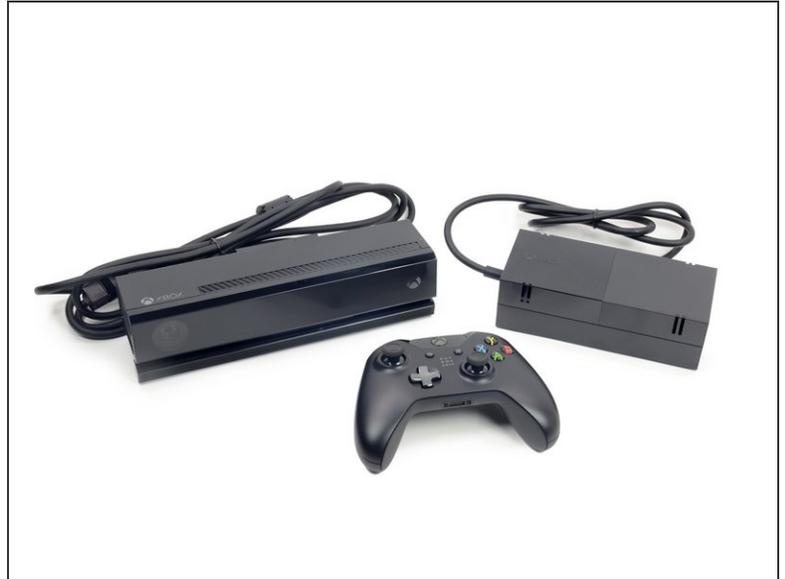
Step 3

- The Day One Edition includes a commemorative controller, with appropriate inscription smack dab in the middle: "Day One 2013."
- The design of the Xbox One controller builds on that of the Xbox 360 controller, with a few updates.
- The development cost for the Xbox One controller exceeded \$100 million, according to [a Microsoft representative](#). Some of the prototypes featured built-in displays and cameras, a cartridge for emitting smells, and even a built-in projector.
- Also tumbling out of the, er, box: the Kinect 2.0 unit and a [miniature Xbox One](#) enormous power brick.

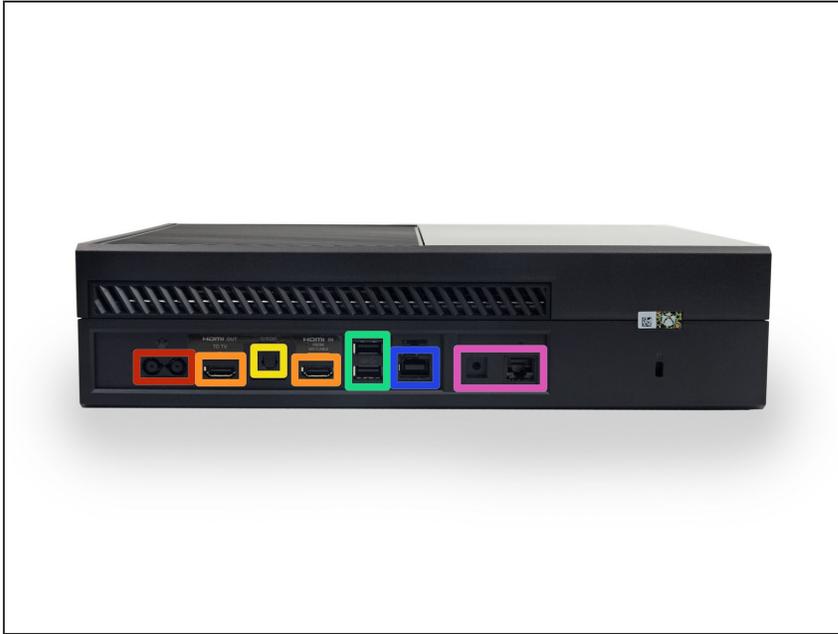
Step 4

- 'Round the back of the console, itself, we find:
 - Power Inlet
 - HDMI Out (left) and HDMI In (right)
 - Digital Optical Audio Out
 - Two USB 3.0 Ports
 - Kinect Port
 - Infrared Output and Ethernet Port
- Possibly up to no good is a roguish third USB 3.0 port, manning the left side all by itself.

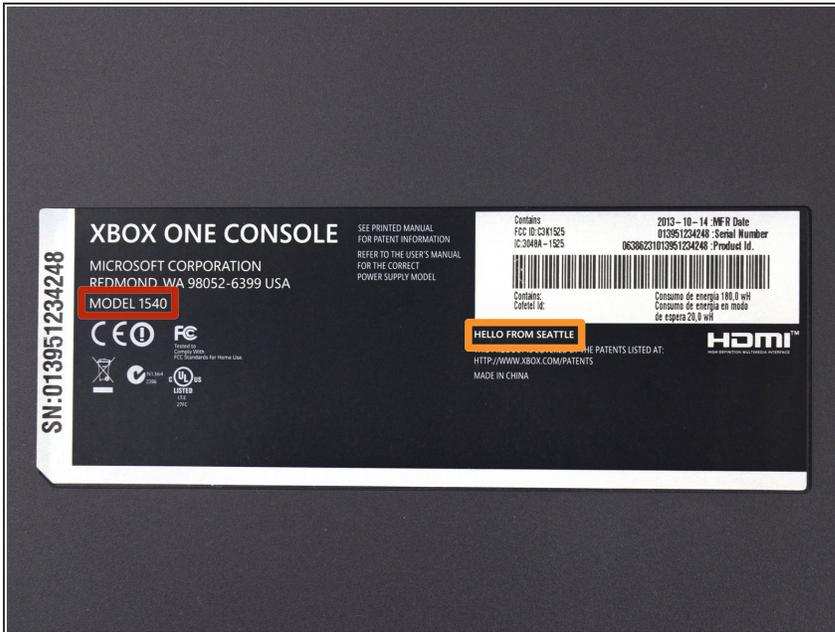
Step 5

- Making our way to the bottom, we check the tags to find...power ratings in Spanish?
- ⓘ El Xbox One consume 180 Wh de energía y en modo de espera consume 20 Wh.
- The Xbox One is identified as model 1540 and was designed by the Microsoft Corporation in Redmond, WA.
- Our Xbox One was manufactured on October 14, 2013 in China.
- And, in friendly words across the back, Microsoft says "Hello From Seattle."

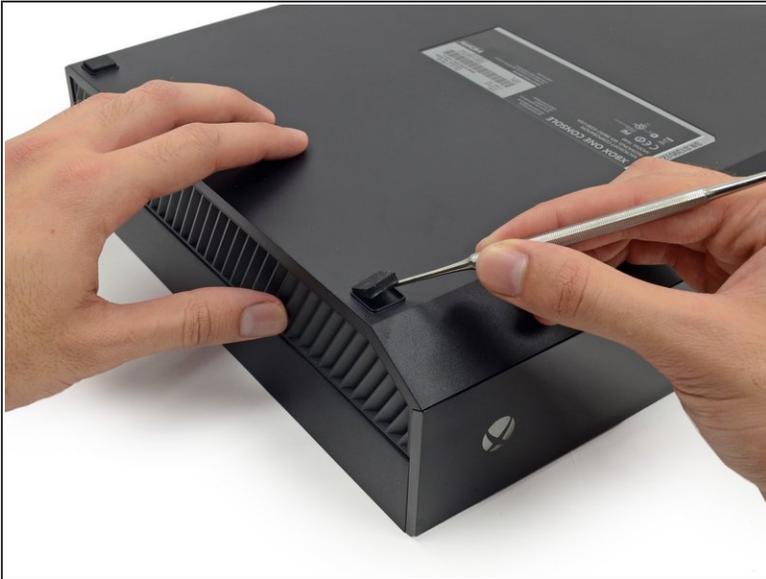
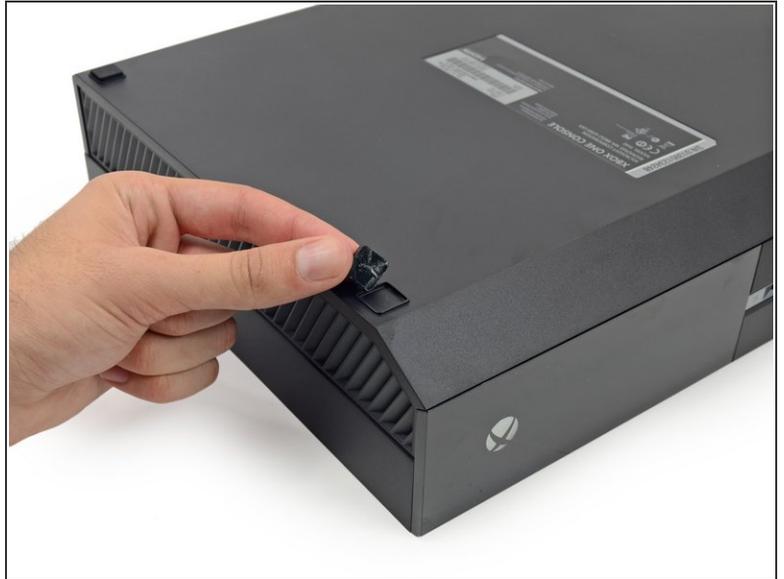
Step 6

- In hopes of finding some screws, or other magical entry point, we channel our inner dentist and use a metal spudger to remove the plaque rubber feet from the console.
- Just like sitting in the dentist's chair, we have no luck here. No screws. No easy way in. Novocaine, please!

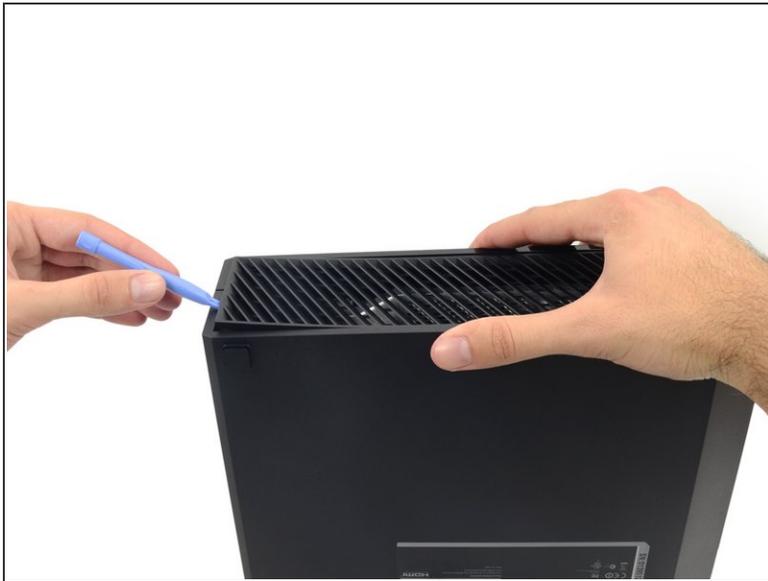
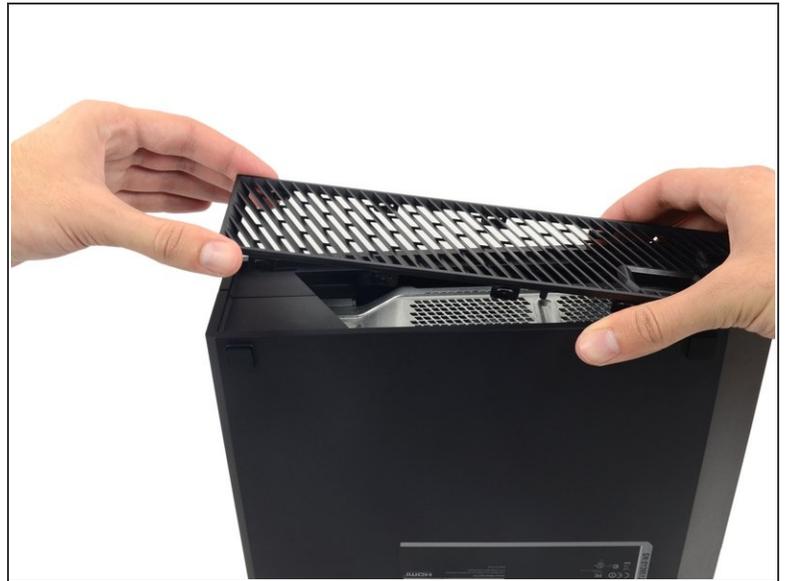
Step 7

- [Don't panic](#); we're prepared.
- Despite the lack of screws, we find a way in with a plastic opening tool—prying the grille up.
- ⓘ This is similar to the [Bottom Vent](#) disassembly procedure in the Xbox 360.

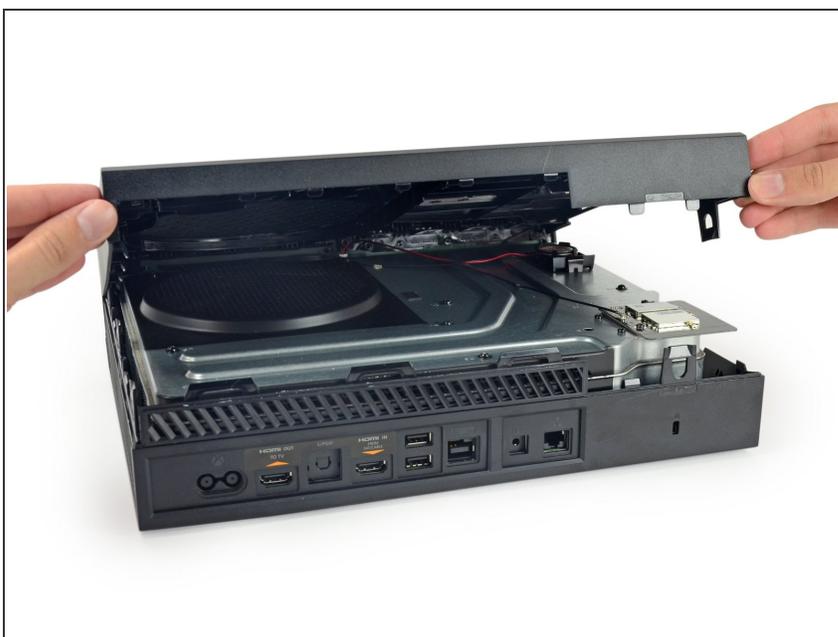
Step 8

- *Speak, friend, and enter.* Giving the right password and freeing some clips, we gain access to the innards of the Xbox One.
- We flip open the top case, granting us a peek at the ~~mines of Moria~~ dark chambers within.
- While our first peek doesn't reveal much, we are ready to venture through shadow and circuit...

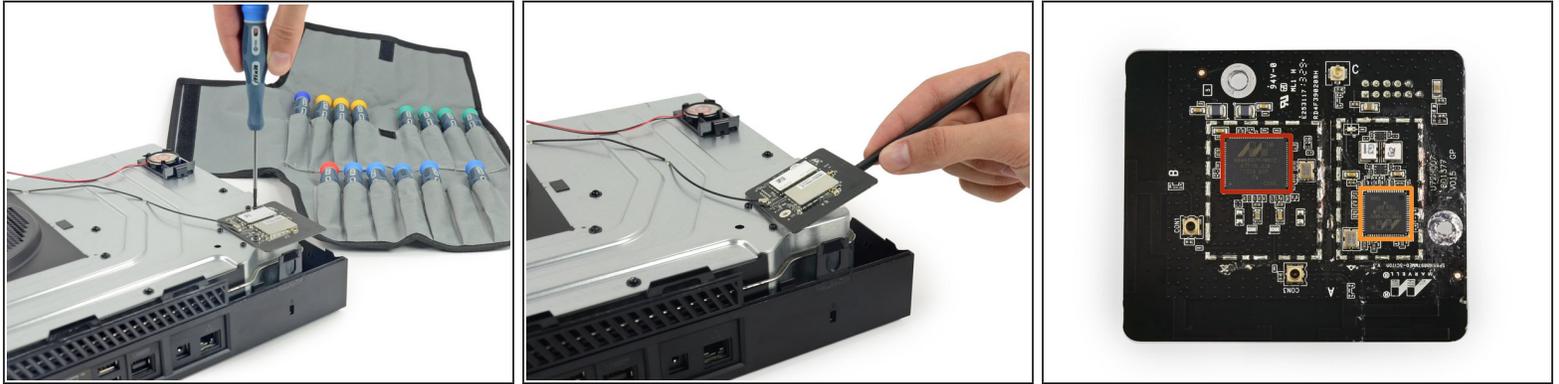
Step 9

- Our Pro Tech Screwdriver Set is almost as anxious to get into this console as we are.
- The Pro Tech set was much easier to get through customs than our [backup opening tools](#).
- While we're not sure how they stand up against orcs, our screwdrivers are awesome for removing the small screws holding the Wi-Fi board in place.
- A quick wave of our spudger, and the Wi-Fi board is out and ready for inspection.
 - Marvell Avastar [88W8897](#) 2x2 MIMO Wi-Fi Combination Radio Chip Supports 802.11ac, NFC, Bluetooth and Wireless Display
 - Marvell Avastar [88W8782U](#) WLAN SOC w/USB 2.0 Interface Support

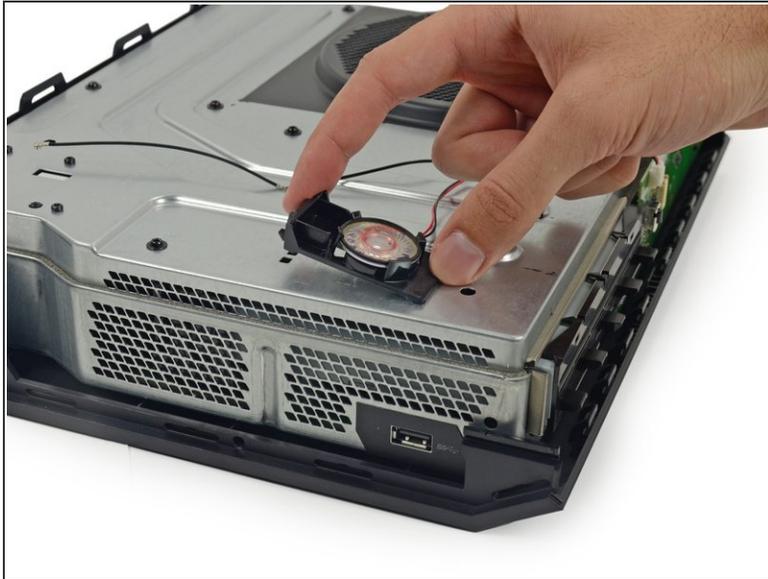
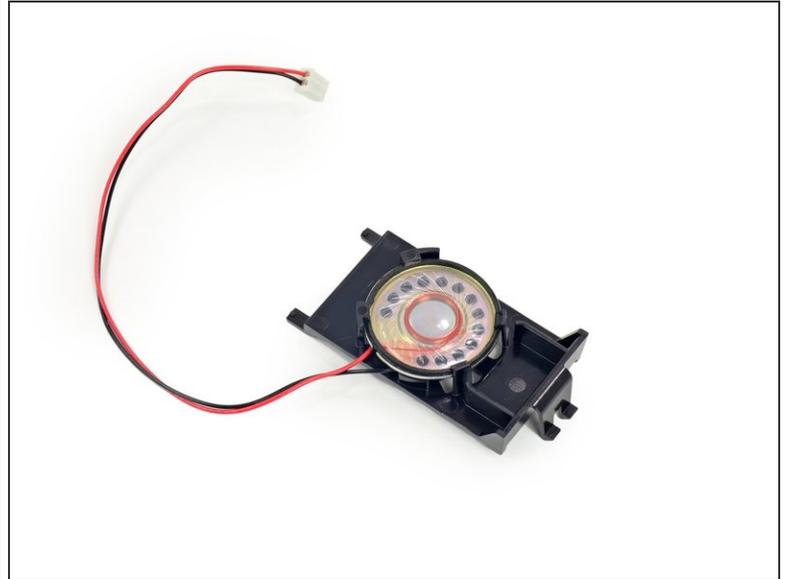
Step 10

- This is interesting. And by interesting we mean unique. We've uncovered a speaker inside the Xbox One. Or it could be an early prototype of an arc reactor. Probably a speaker.
- We're happy that this speaker is held in place with a simple plastic bracket—no tools required.

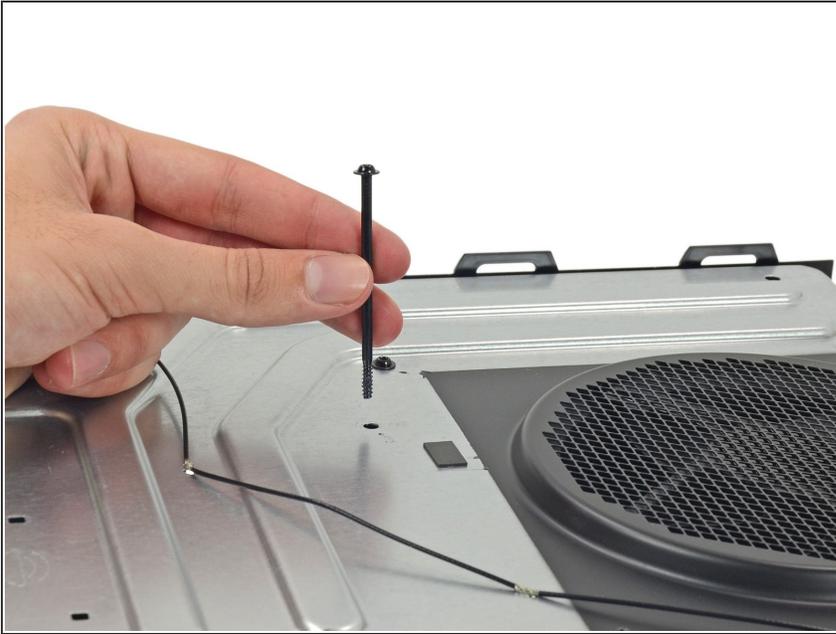
Step 11

- There are eight 64 mm T9 Torx screws securing the upper metal shield to the chassis.
 - ⓘ That is just over two-and-a-half inches of threaded fun!
- Game consoles are one place where we haven't seen the smaller, lighter, thinner trend taken to extremes—and we're okay with that. We like a device with a little meat on its bones, if it means finding standard fasteners like these screws—a win for repairability.
 - ⓘ Small, light, and thin **can** be [repairable](#) too! We've [seen it](#) happen.

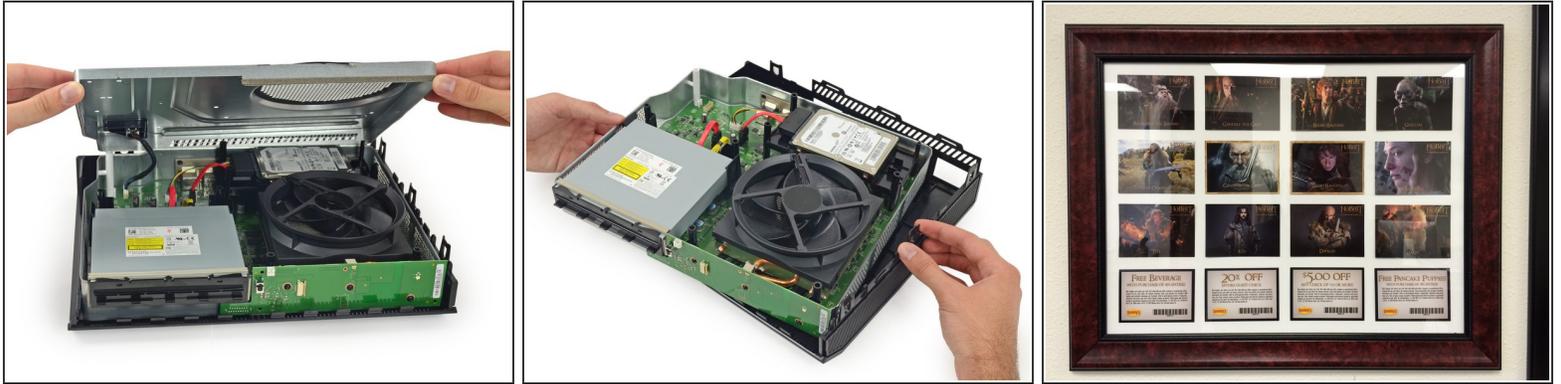
Step 12

- This is our first real glimpse inside the Xbox One.
- Well, that was easy. The entire Xbox One assembly simply lifts off from the lower case.
 - We appreciate a mystery, wrapped in an enigma, hidden inside a [hobbit hole](#) as much as the next person, but for repair purposes, it's nice when things are a little more straightforward.
 - How much do we care about the Hobbit Hole breakfast at Denny's? Oh, you know...

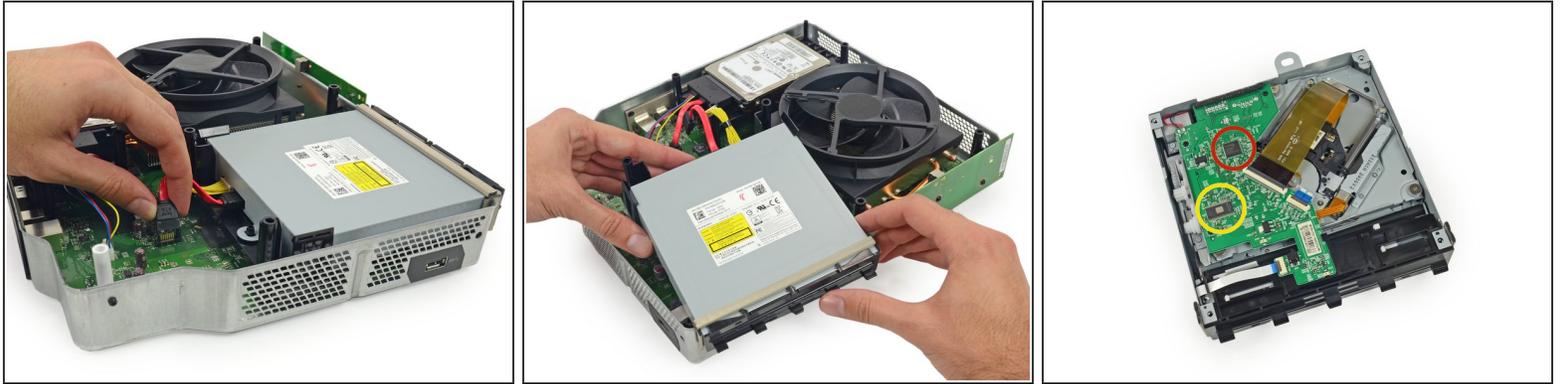
Step 13

- In another win for repairability, the Blu-ray/DVD drive is connected to the motherboard via a SATA data connector.
- While we are tempted to re-watch the entire LOTR trilogy on Blu-ray, our own quest to destroy the One Xbox in the fires of the teardown table is more dire.
- We take a look at the underside of the optical drive, finding a few ICs and a large ribbon cable:
 - Microsoft MS0DDDSPB1 1326-BTSL ATNGS501
 - Texas Instruments 37T AVY7

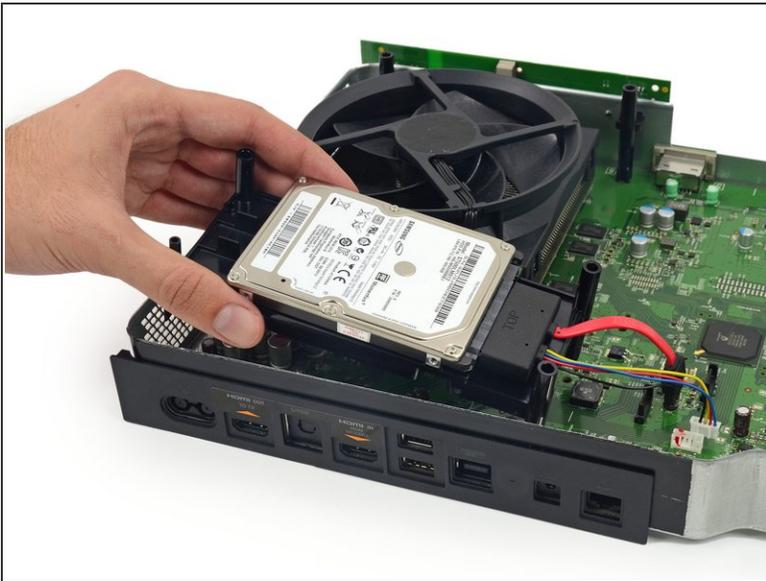
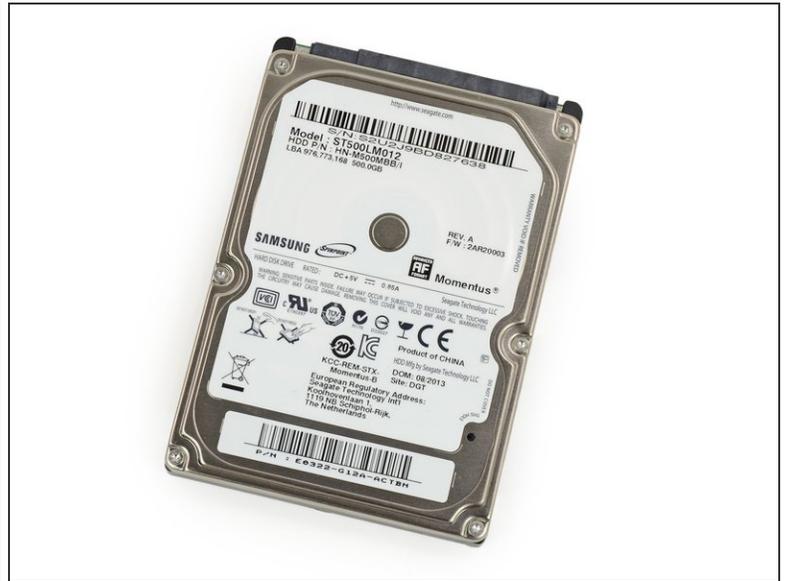
Step 14

- Unfortunately, the Xbox One doesn't *officially* feature a replaceable hard drive—but then, we're not much for playing by the rules. Out it comes.
 - Bad news: replacing the hard drive requires voiding the warranty. Good news: it's a standard 2.5 inch SATA II drive. Sad news, the Xbox One doesn't support unformatted hard drives.
 - Inside our Xbox One, we find a Samsung Spinpoint M8 [ST500LM012](#) 500 GB 5400 RPM with 8MB Cache SATA II 3.0Gb/s hard drive.
- ⓘ [Newegg](#) seems to have favorable reviews of this drive.

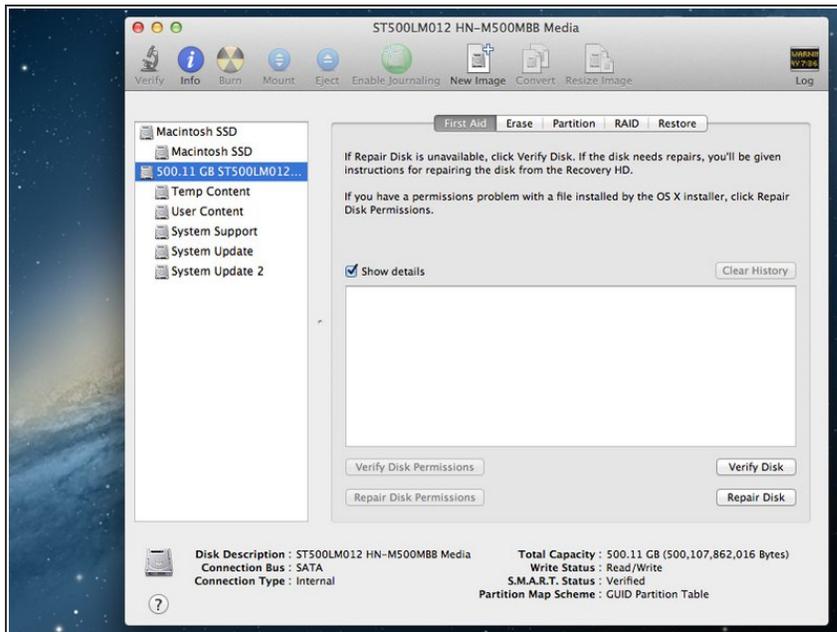
Step 15

- **Teardown update:** We tossed the One's hard drive into one of the tech writers' [secondary hard drive bays](#). We found **five** NTFS partitions:
 - *Temp Content:* 44 GB capacity, 27.1GB available (in an Xbox that we never turned on).
 - *User Content:* 391.9 GB capacity, none used.
 - *System Support:* 42.9 GB capacity, 34.1 GB available.
 - *System Update:* 12.8 GB capacity, 11.8 GB available.
 - *System Update 2:* 7.52 GB capacity, 7.47 GB available.
- Sadly, we were not able to go the other way -- we didn't have a spare hard drive (in New Zealand) to put into the Xbox One. So that will have to wait for another day!

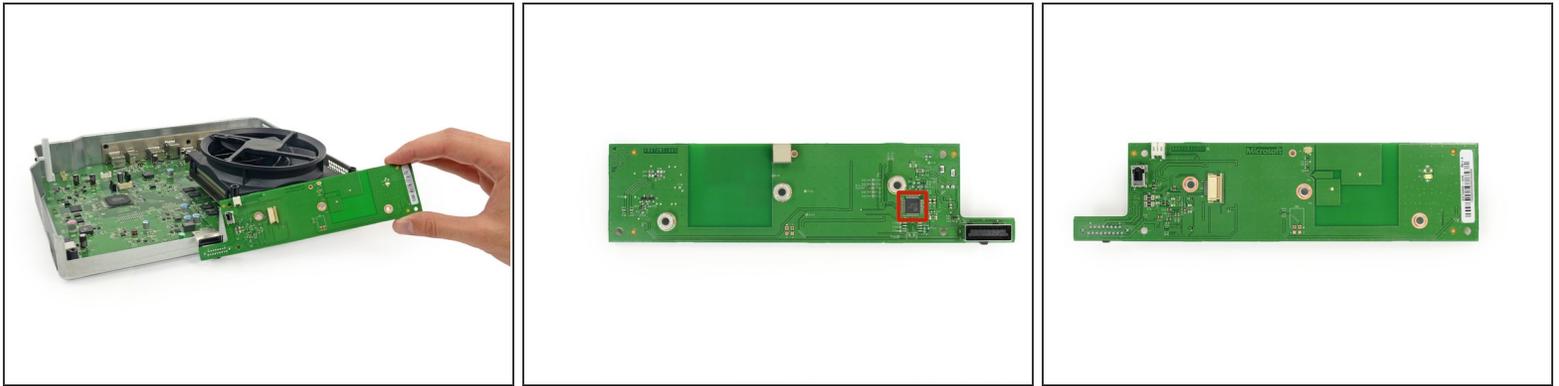
Step 16

- The RF Module board detaches outward from the lower case.
- The back of the RF Module board features one lone IC from Info Storage Devices labeled 9160F1MS03 1327 2317B057. We believe this is an Audio User Interface chip from [Nuvoton](#).

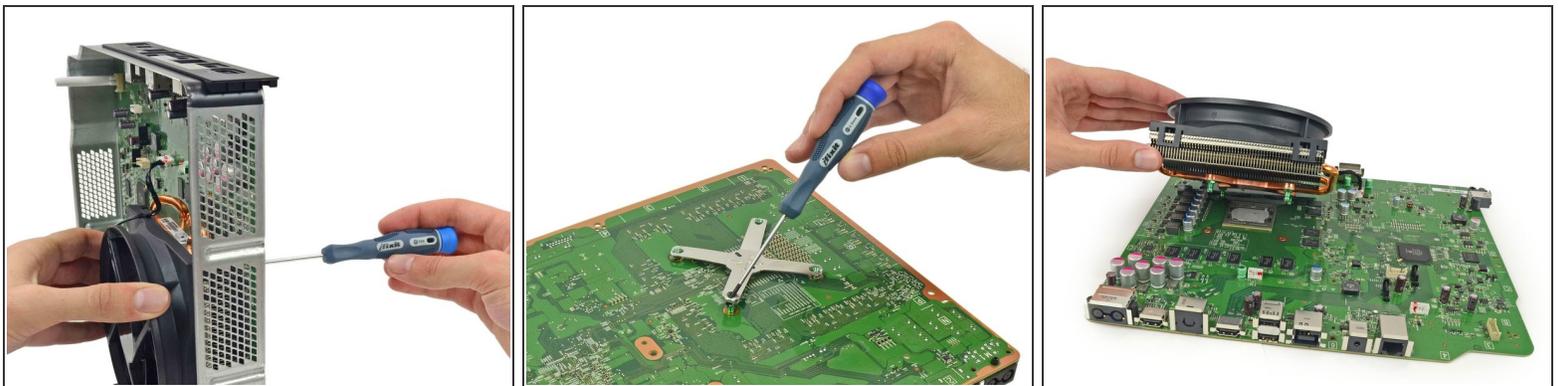
Step 17

- "X" marks the spot. The heat sink/fan assembly is secured to the motherboard with a few T9 Torx screws.
- ⓘ After the infamous [red ring of death](#), we're not surprised to see a beefy cooling system on this Xbox.

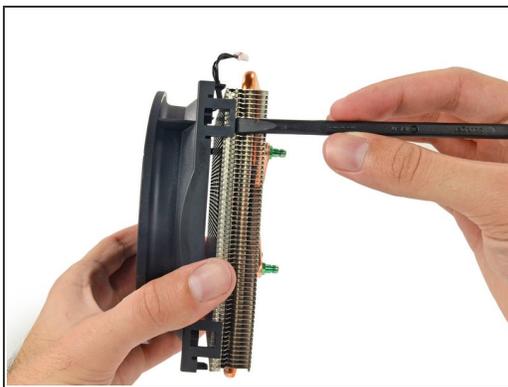
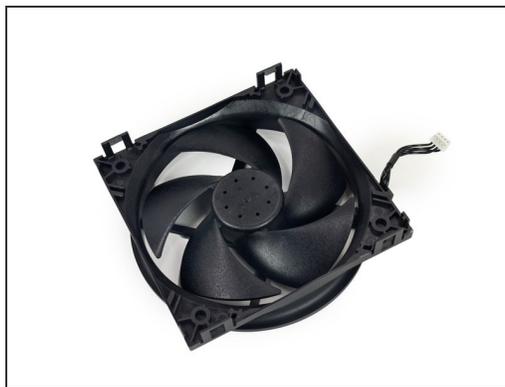
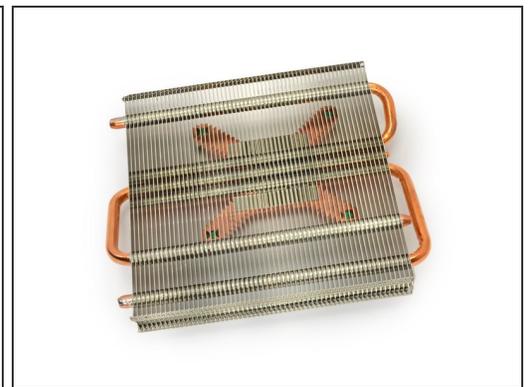
Step 19

- We're happy to report that, should your new Xbox One have cooling issues, replacing the fan or heat sink is easy-breezy.
- All it takes is a simple flick of the spudger to separate the 112 mm diameter fan from the heat sink.
- ① That's one small step to replace, one giant leap for repairability.

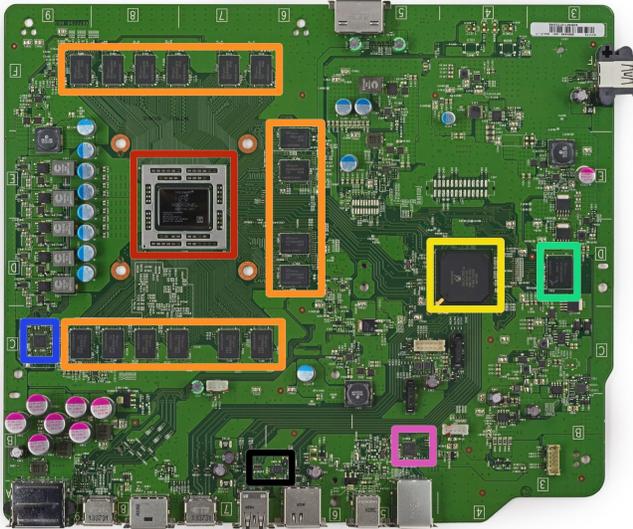
Step 20

- What do our elf eyes see? An army of integrated circuits. The heavy hitters include:
 - X887732-001 DG3001FEG84HR (includes AMD "Jaguar" 8-core CPU + AMD Radeon Graphics GPU)
 - 16x SK Hynix [H5TQ4G63AFR](#) 4 Gb (512 MB) DDR3 SDRAM (total of 16 x 512 MB = 8 GB)
 - X861949-005 T6WD5XBG-0003
 - SK Hynix H26M42003GMR 8 GB eMMC NAND Flash
 - ON Semiconductor NCP4204 GAC1328G Integrated Power Control IC
 - Realtek RTL 8151GNM Ethernet Controller
- Texas Instruments [TPS2590](#) 3-V to 20-V High Current Load Switch

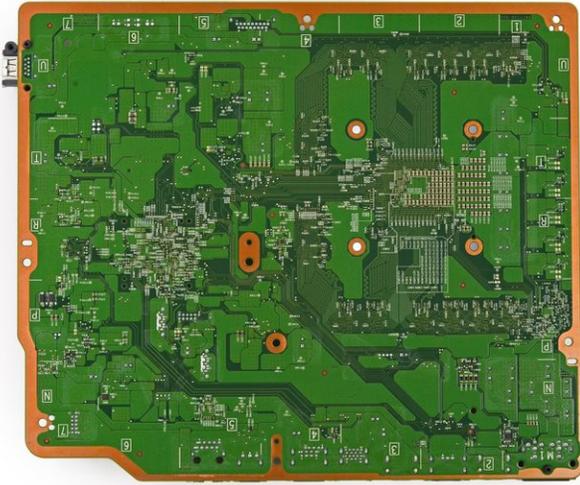
Step 21

- The backside of the motherboard is a glorious, green field, void of any integrated circuits.
- As always, a big thanks to the folks at [Chipworks](#) for helping us determine names of the doodads we found inside the Xbox One!
 - If you haven't, already, check out their in-depth [analysis of the PS4!](#)

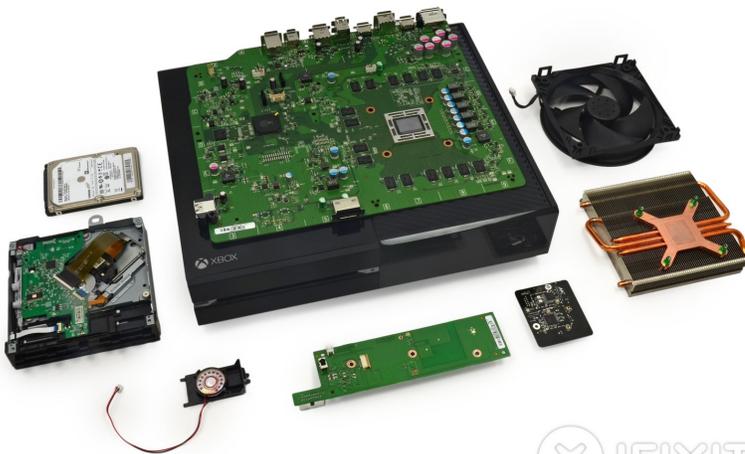
Step 22

- With that, game time is over! Let's tally up this console's repairability score.

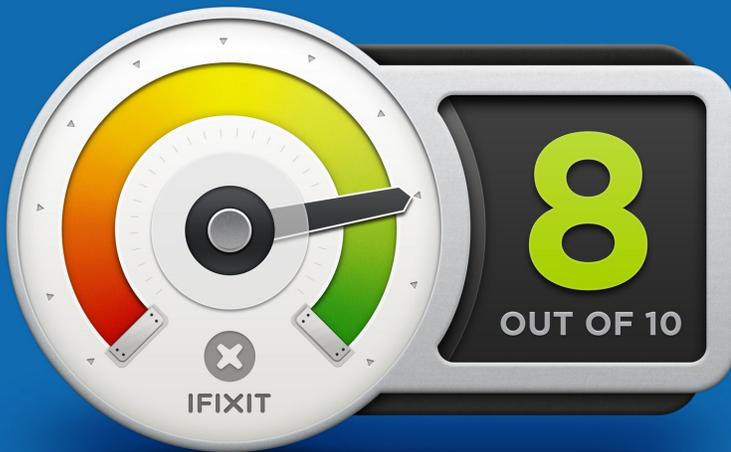
REPAIRABILITY SCORE:

- Microsoft Xbox One Repairability Score: **8 out of 10** (10 is easiest to repair):
 - Only a few tools are required to take the whole console apart. The opening procedure is similar to, but much easier than, any Xbox 360.
 - Once inside, a clean, no-nonsense modular design allows the drives, fan, heat sink, wireless board, and front daughterboard to be easily replaced.
- Clips instead of screws make opening the case more difficult than necessary, but the absence of adhesive and proprietary screws helps soften the transgression.
- The hard drive is relatively difficult to access; you'll have to void the warranty if you'd like to upgrade/replace it.
