# Oculus Rift Development Kit 2 Camera Motherboard Replacement

This guide leads the user through the replacement steps for the Oculus Rift Development Kit 2 camera motherboard.

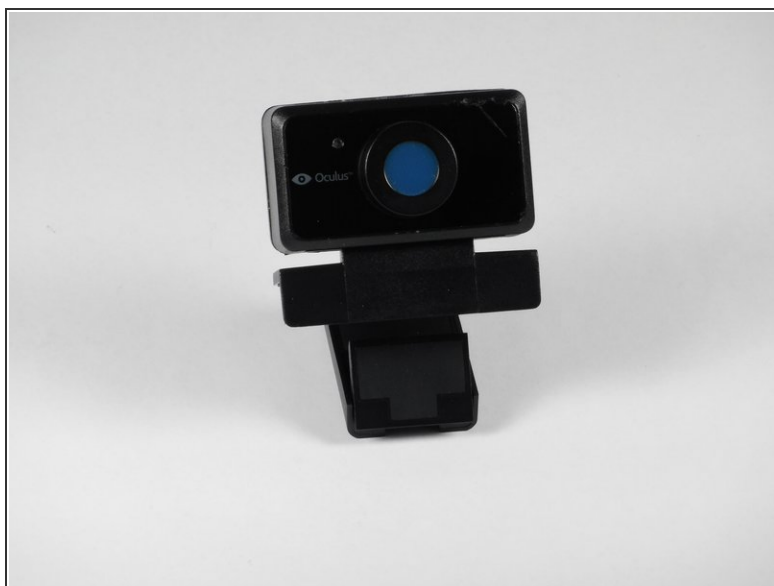
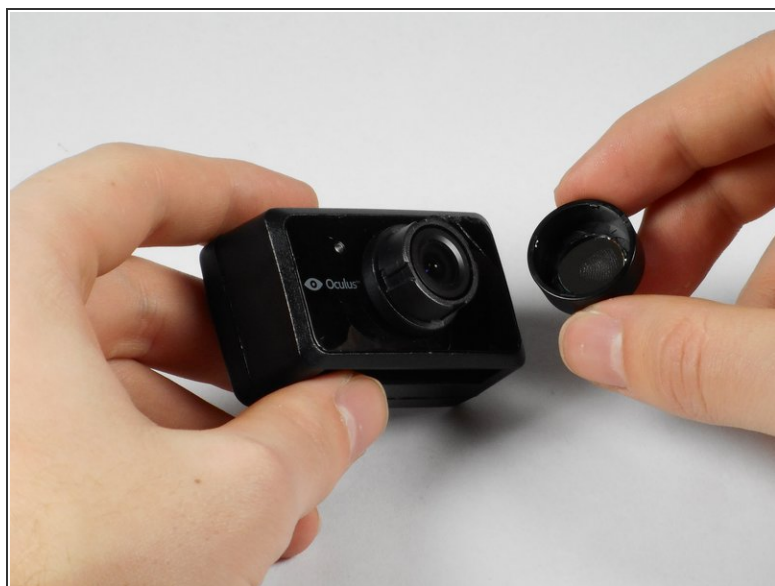
## Step 1 — Camera Motherboard

- Remove the filter from the camera as shown.

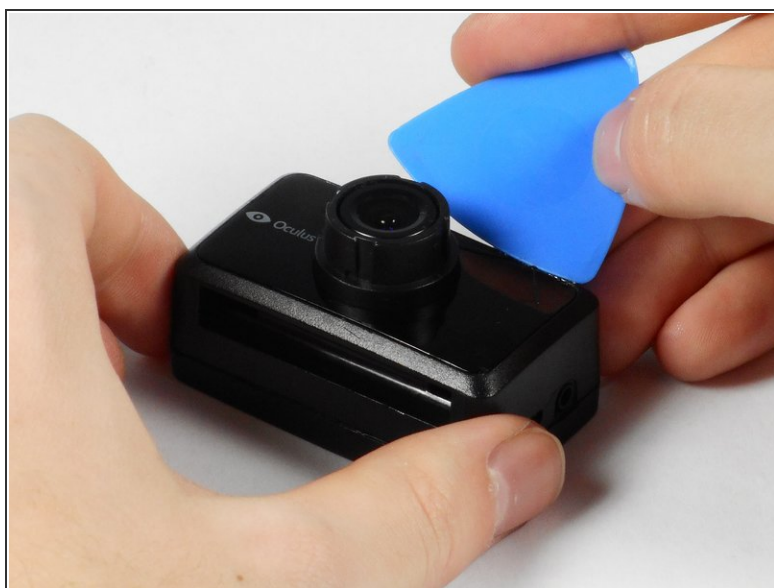
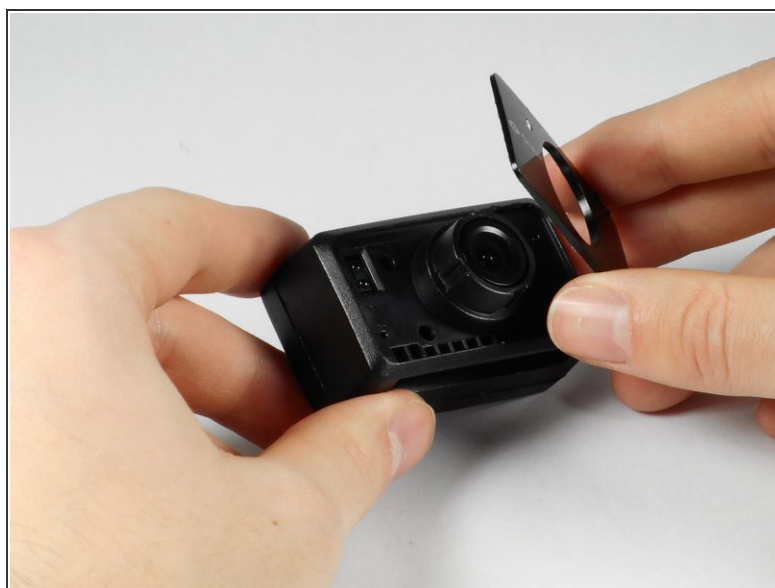
## Step 2

- Remove the cover plate from the front face of the camera using the iFixit Opening Pick.
