Canon DM-100 microphone rattle noise fix

Written By: Bonka

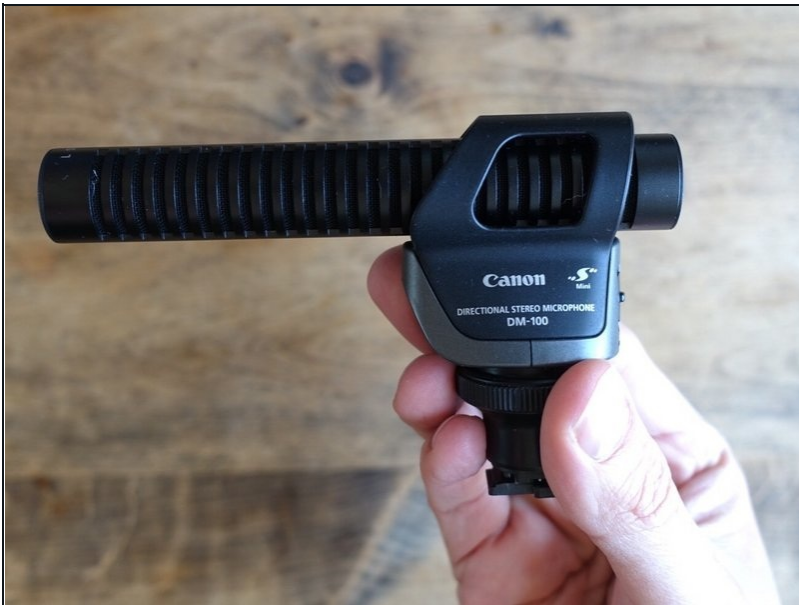
Step 1 — The Mic

- This is the rattly beast.

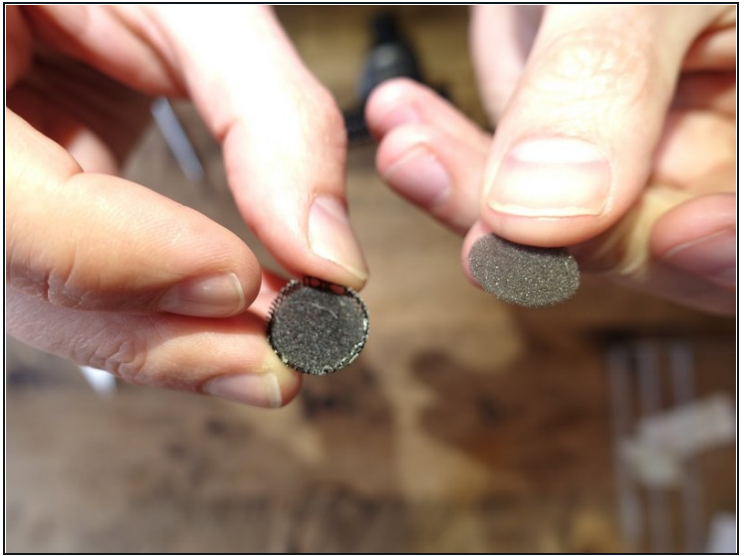
Step 3 — The culprit

- Canon has used an elastic band for vibration reduction of the directional "sound pipe" (seen as a circle behind the elastic band).
- The pipe visible behind the elastic is supposed to be mounted to the inner wall with the two marked circular joints.
- These incredibly weak joints are bound to break as the rubber loses its elasticity.

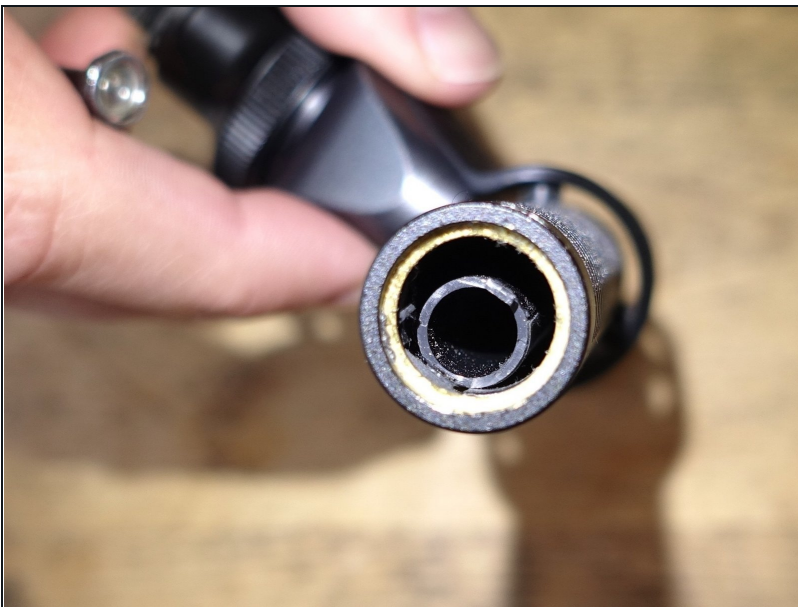
Step 5 — Clean slate

- The culprit of the rattling noise is now apparent. A plastic cylinder stretches through the whole of the microphone, enabling the microphones forward focused / directional sound.
- When the rubber band breaks because of the bad joints, this thing hits the inner side of the cylinder.

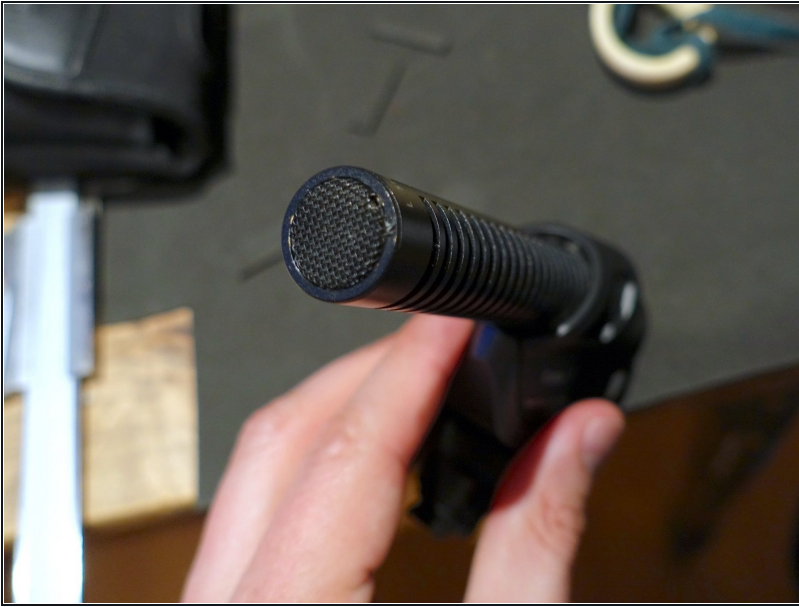
Step 10 — Done

- There! 190\$ microphone fixed for less than a dollar.
- The audio quality isn't affected at all.
