Microsoft Band 2 Buttons Replacement

This guide will show you how to remove the side buttons on the Microsoft Band 2.

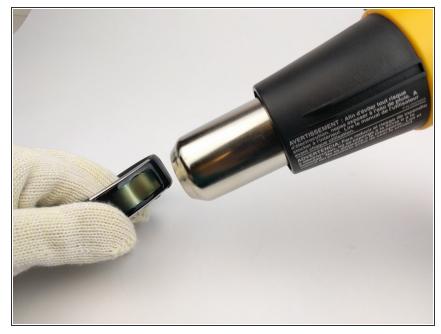
Step 1 — Screen

- Wear proper gloves when using a heatgun.
 - Use a heatgun to melt the adhesive beneath the screen. Heat the metal around edges of the screen.
- Avoid heating the rubber watch band as it will quickly melt.
- i Heating the LCD screen may damage it. Avoid this procedure unless you intend to replace the screen.

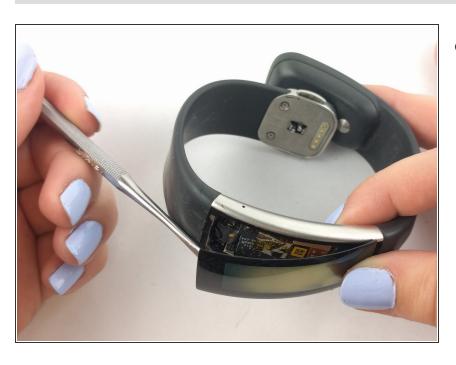
Step 2

Use a <u>spudger</u> and plastic <u>opening</u> <u>picks</u> to pry the screen away from the Band 2.

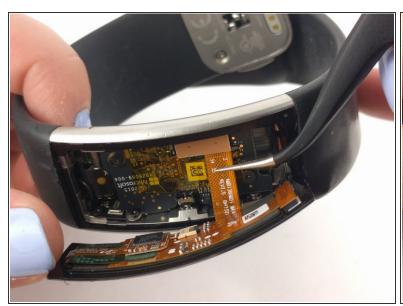
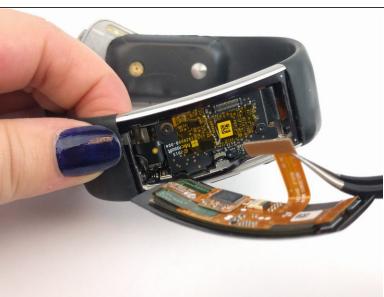
Step 3

Use metal tweezers to gently detach the orange press-fit (or "pop") connector.

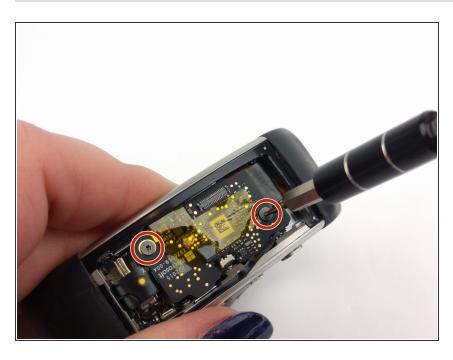
Step 4 — Buttons

Use the T3 Torx Screwdriver to remove the two 2.7 mm screws

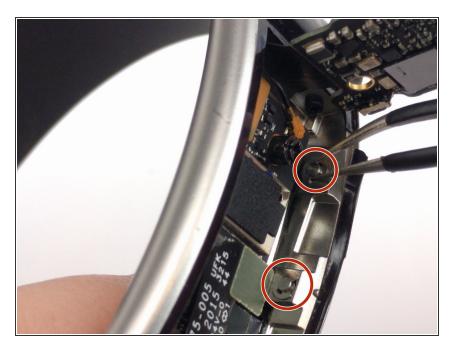
Step 5

Lift the logic board and locate the two circular clips securing the buttons from inside the wall of the Band 2. Remove them by sliding the clips sideways.

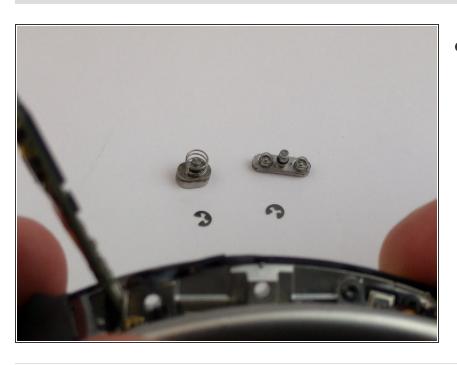
Step 6

Remove the buttons, being careful not to lose the springs.
