# HP Pavilion 15-au123cl CD Drive Replacement

Incase your CDs and DVDs aren't working, you can follow this guide to replace your CD Drive for the HP Pavilion 15-au123cl.

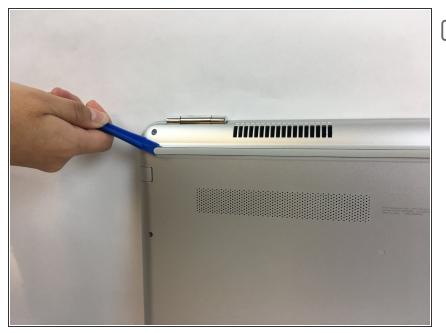
#### Step 1 — Battery

- Make sure the laptop is off and unplugged before starting.
- Using the plastic opening tool, remove the top rubber feet on the back panel as it hides one of the screws we will be removing.

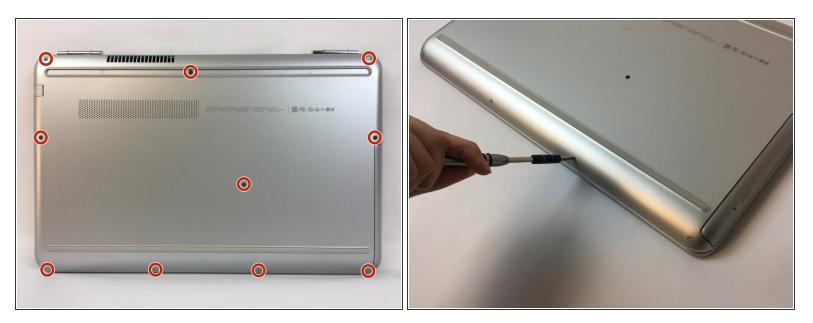
#### Step 2

Using a PH0 screwdriver, unscrew the ten 4.4mm Phillips head screws located on the back panel.

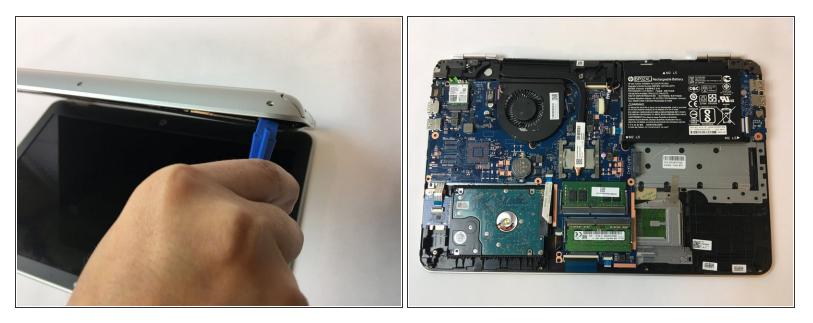
## Step 3

- Using the plastic opening tool, remove the back cover of the laptop.
- (i) It is recommended that you start with a corner and run the tool throughout the edges of the cover.

A Be sure not to bend the cover by applying too much force.

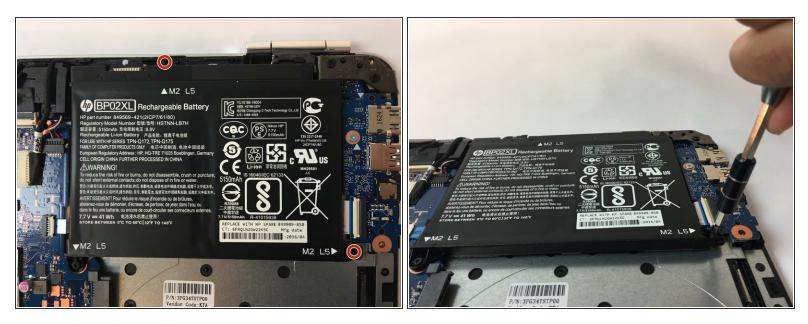
## Step 4

Using a PH0 screwdriver, unscrew the two 3.8mm PH0 Phillips head screws that hold the battery in place.

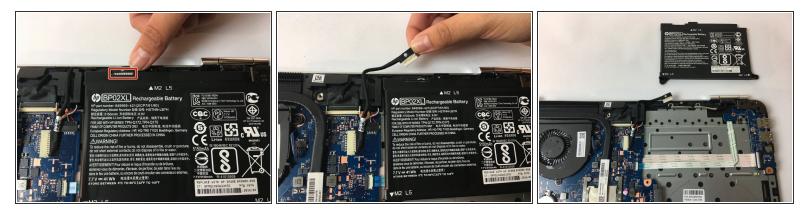
## Step 5

• Carefully disconnect the cable connecting the top of the battery and remove the battery.

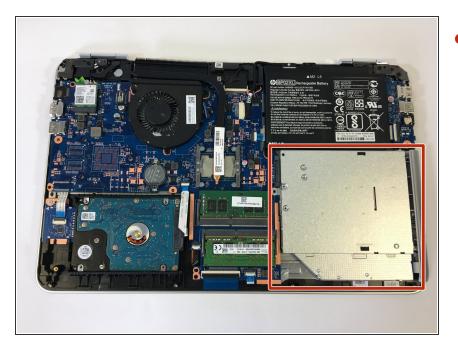
#### Step 6 — CD Drive

The CD Drive is located at the bottom right area of the motherboard.

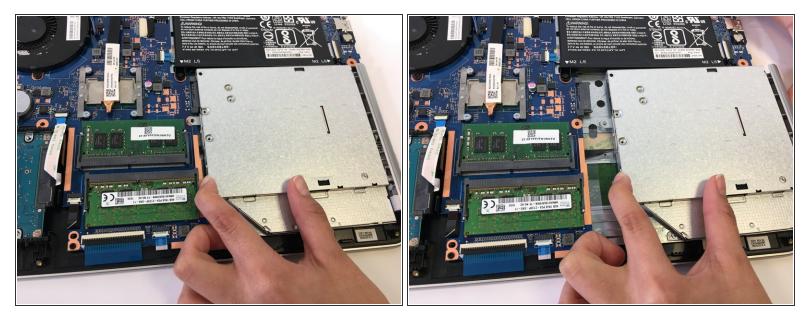
## Step 7

• Disconnect the CD drive from the motherboard connector on the left.

To reassemble your device, follow these instructions in reverse order.
