# Dell VRP100 HDMI/USB Cable Replacement

How to replace the HDMI and USB Type A cable in the Dell VRP100 virtual reality headset.

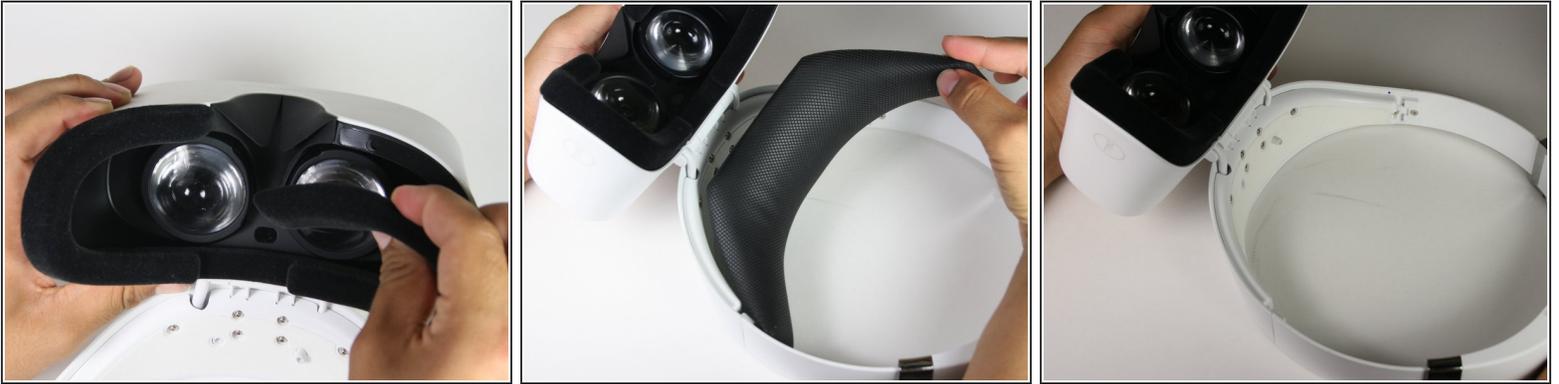
## Step 1 — Cover Panel

- Remove the black foam padding by peeling away slowly.
- Remove the front and back padding from the headset by peeling away slowly.

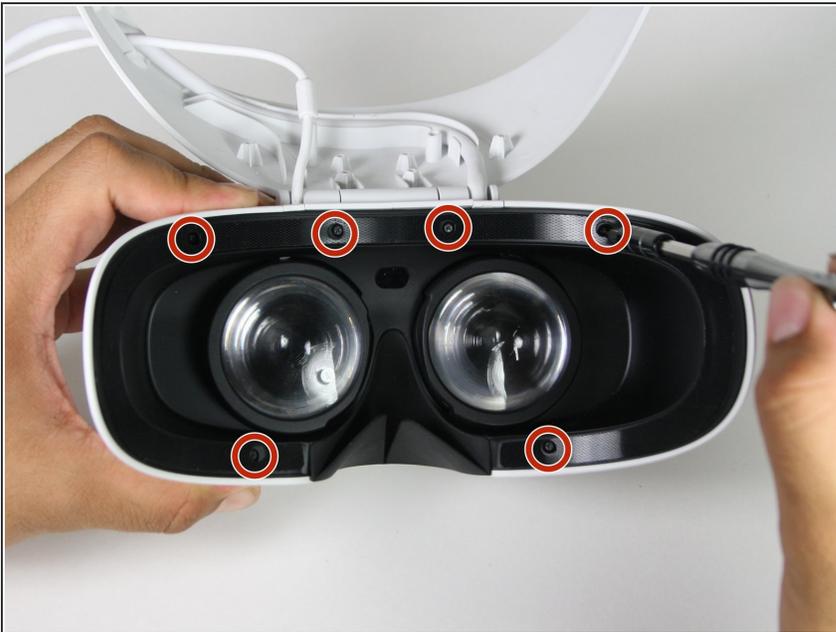
## Step 2

- Remove the six 5.5mm PH000 screws from the cover by rotating counter-clockwise.
- ☑ Cover panel may need to be pushed in before inserting screws.

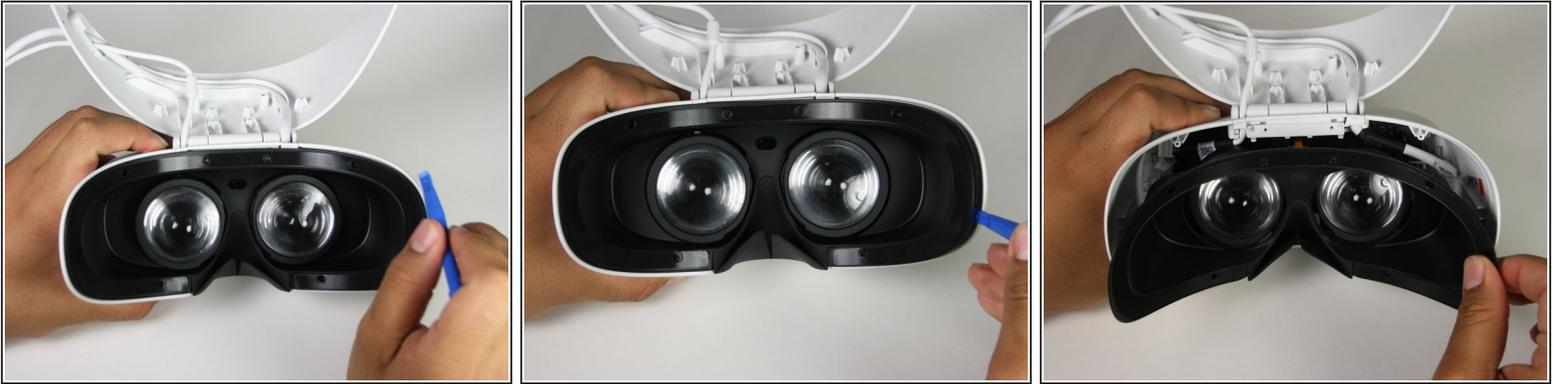
### Step 3

- Remove the cover using one of the plastic opening tools, and then carefully pull it from the casing.

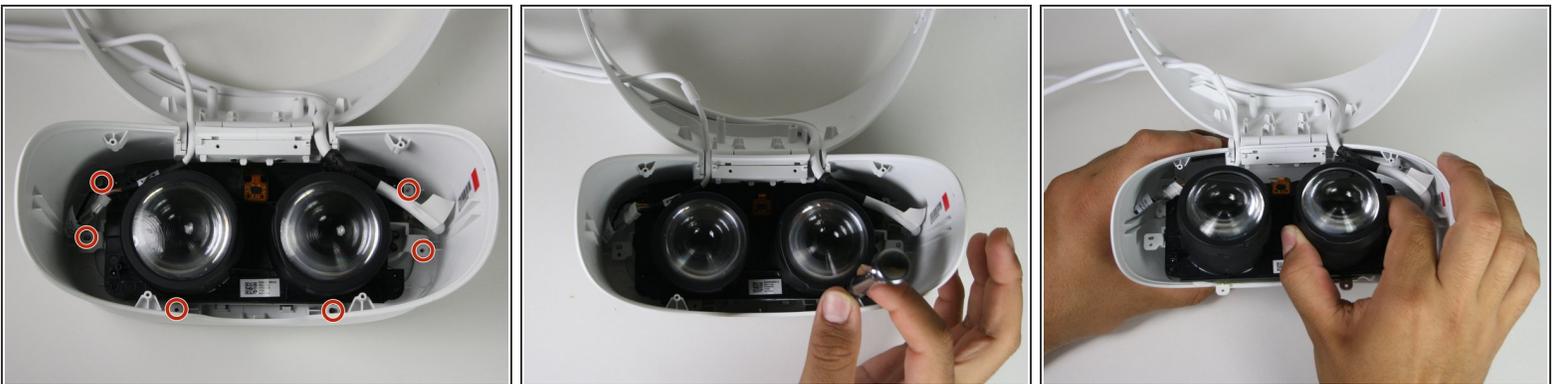
### Step 4

- Remove the six 5.5mm PH000 screws from the cover by rotating counter-clockwise.
- Carefully remove the lens and motherboard assembly from the white casing.

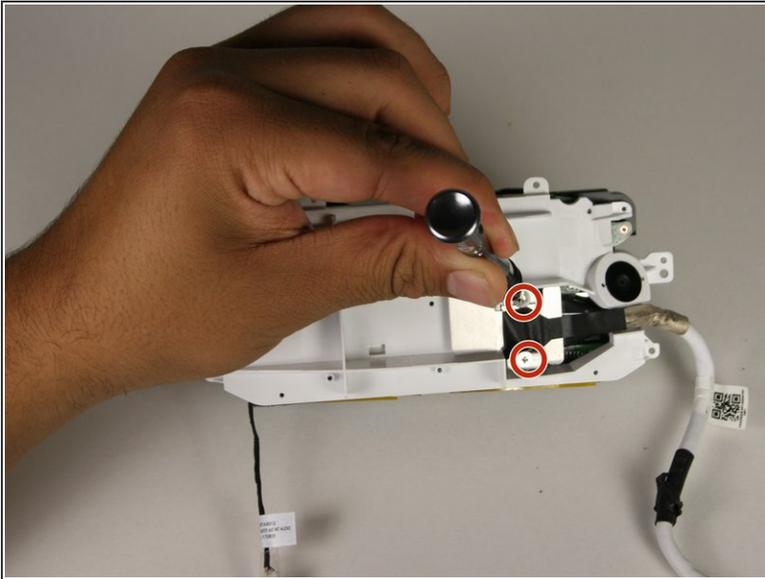
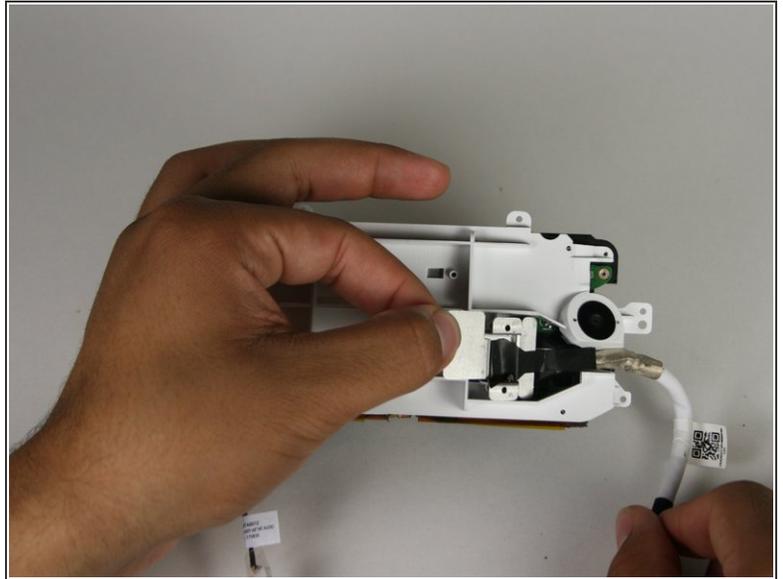
## Step 5 — HDMI/USB Cable

- Remove the two 3.4mm PH000 screws from the cover by rotating counter-clockwise.
- Peel off the tape using your hands or the blunt nose tweezers.

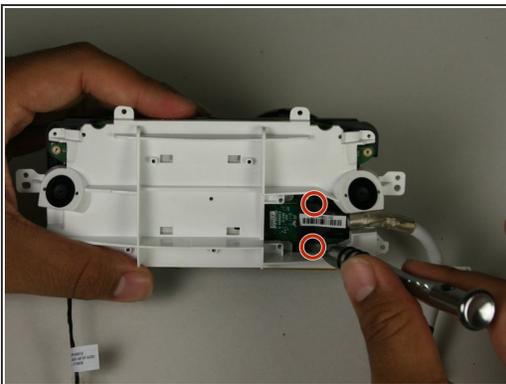
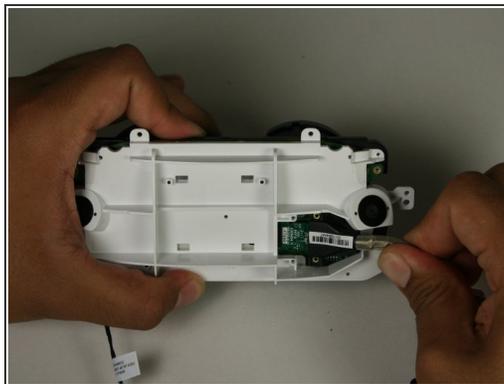
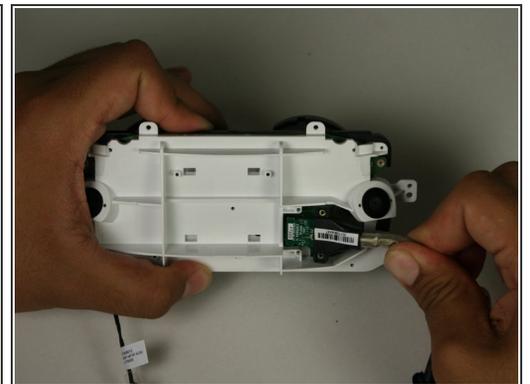
## Step 6

- Remove the two 5.5mm PH000 screws from the cover by rotating counter-clockwise.
- Hold the HDMI/USB cable and remove from the connection.
