Lenovo ThinkPad X1 Yoga Wireless Chip Replacement

How to replace a Lenovo ThinkPad X1 Yoga wireless chip.

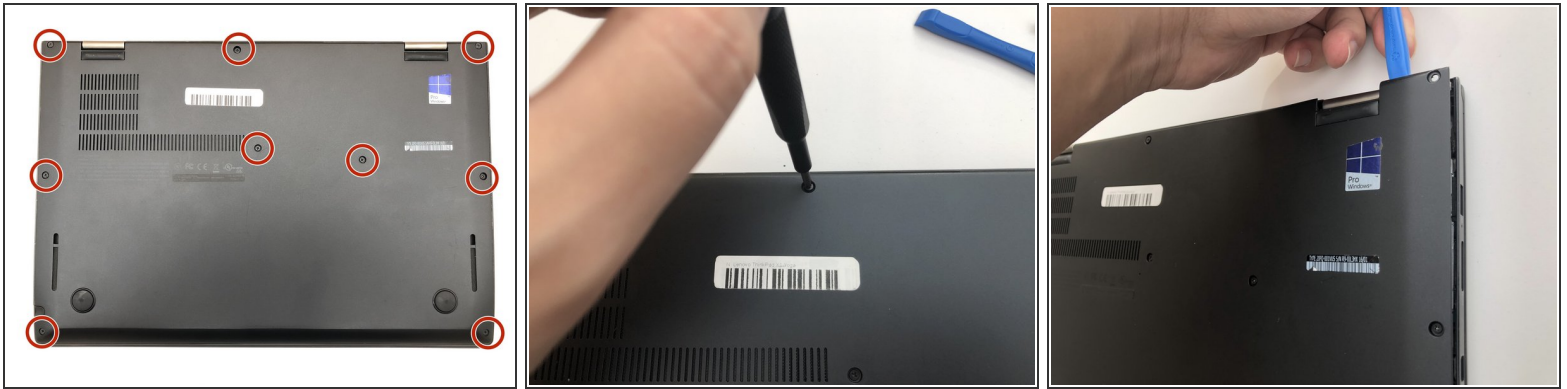
Step 1 — Back Cover

- Flip the computer over so the bottom is facing up.
- Remove nine 4mm Phillips #1 screws from the bottom of the computer.
- Use an iFixit opening tool to pry the back cover off of the laptop.
