HP Media Center 876x Front Cover Replacement

Removal of the front cover of the HP Media...

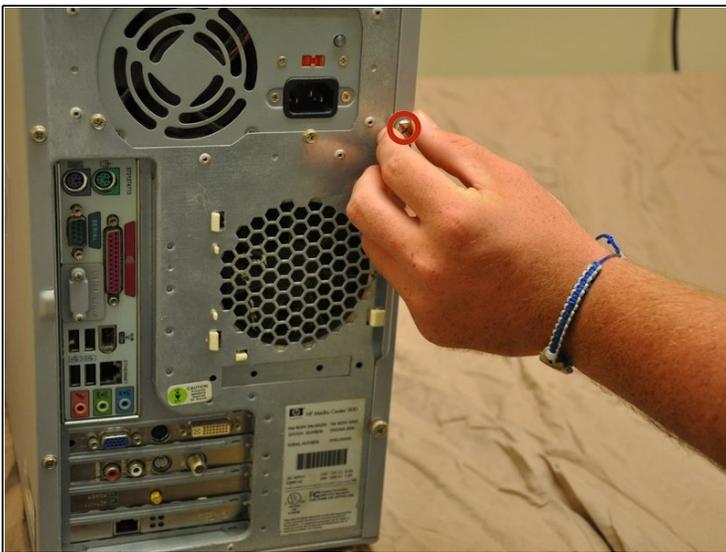
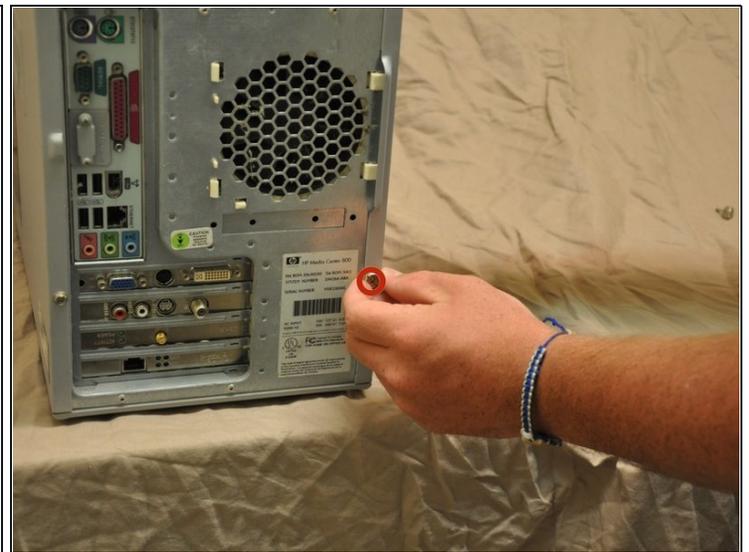
Step 1 — Side Panel

- Remove the two (9 mm) hand screws on the back panel.

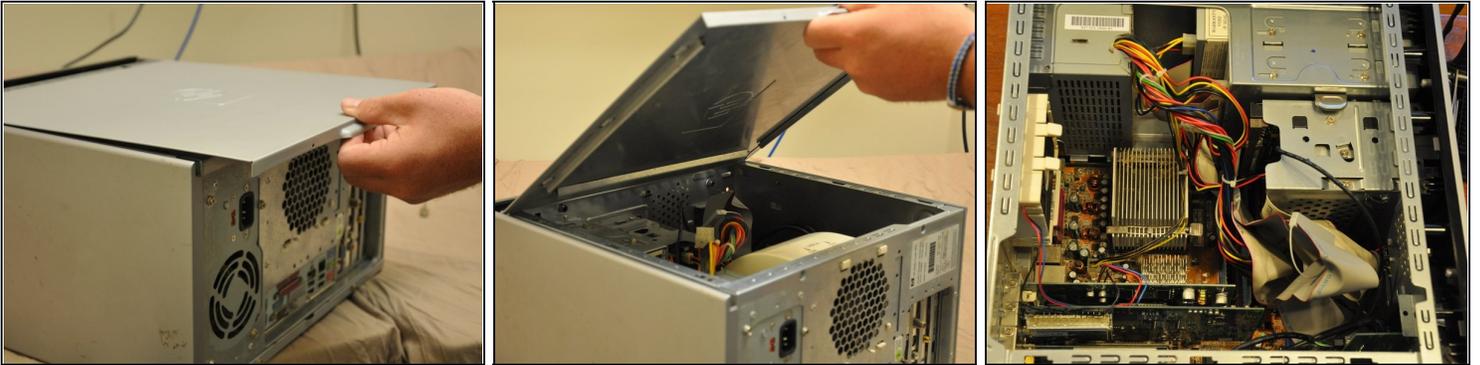
Step 2

- Place the tower on its side.
- Slide the side panel horizontally to detach, and pull upward to remove.

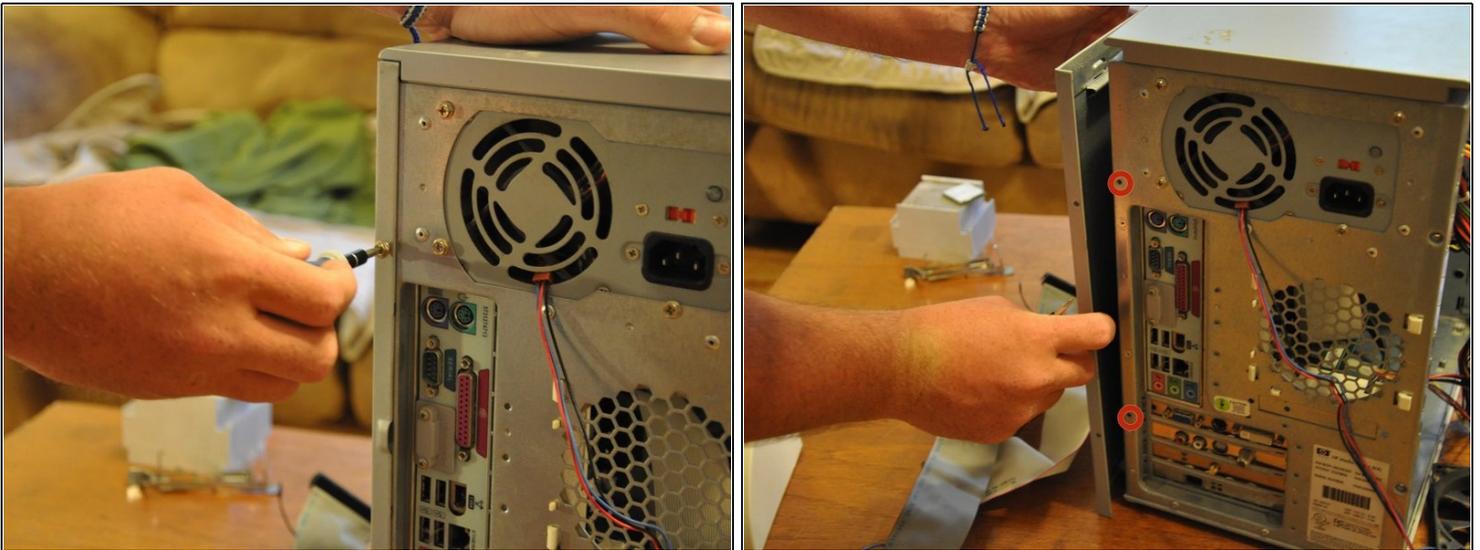
Step 3 — Front Cover

- Orient the tower vertically.
- Using the #0 Phillips head screwdriver, unscrew and remove the two (5 mm) screws that fasten the remaining side panel to the tower.
- Slide the side panel out of its notches, and pull it gently off of the tower.

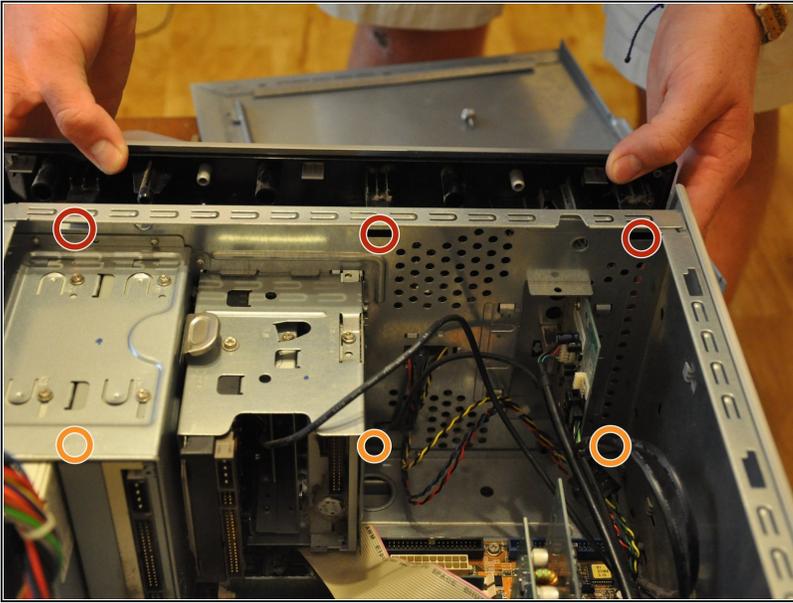
Step 4

- Gently move the tower so that it is in the horizontal orientation.
- Press down the black tabs (proximal to you) that fasten the front panel to the tower.
- Press down on the distal, black tabs (symmetric with respect to the previous tabs).
- Pull front panel forward slightly.

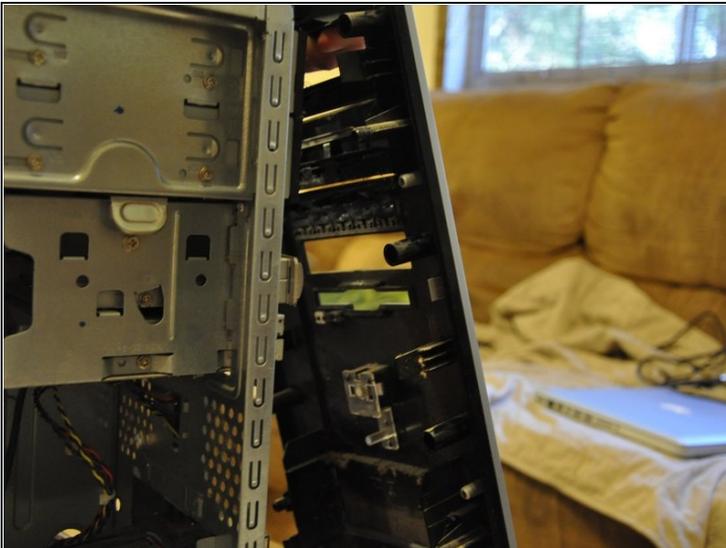
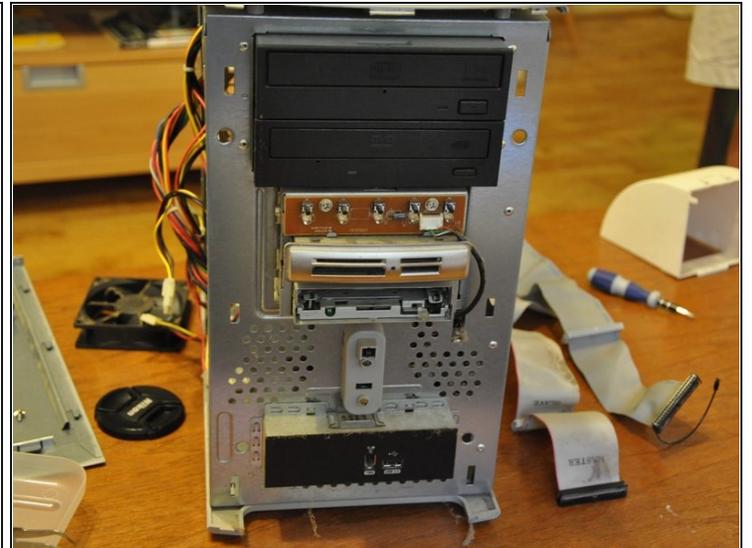
Step 5

- Orient the tower vertically.
- The front panel will come off in a hinge-like fashion, exposing the drives underneath.
