RCA RCT6378W2 Volume Button Replacement

This guide will illustrate faulty volume button removal and replacement.

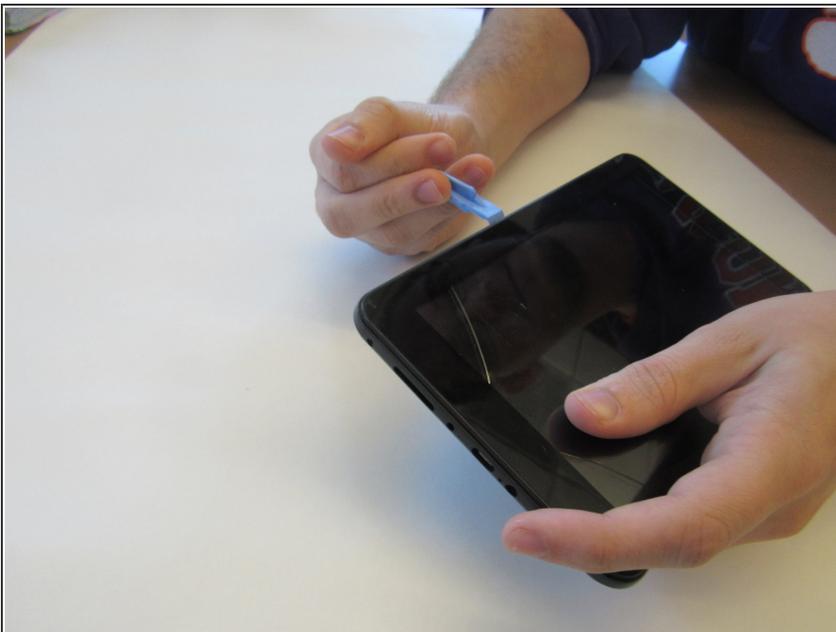
Step 2

- Separate the front and back covers using one of the plastic opening tools.

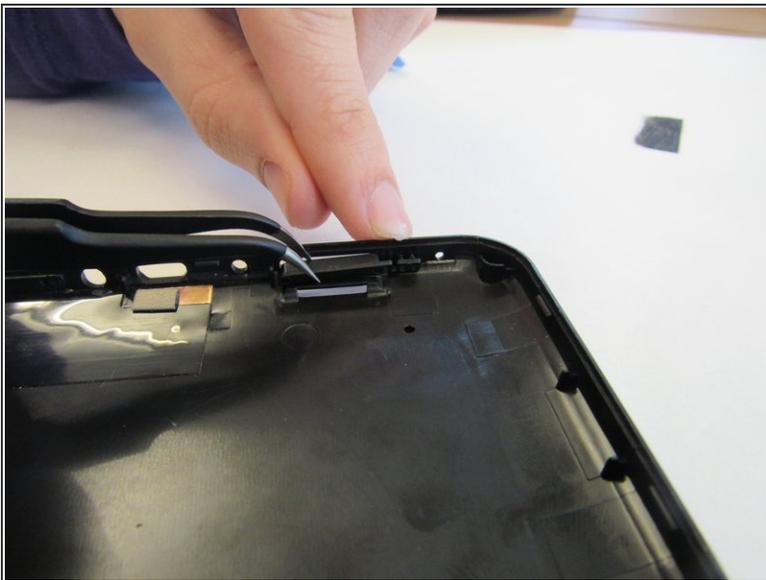
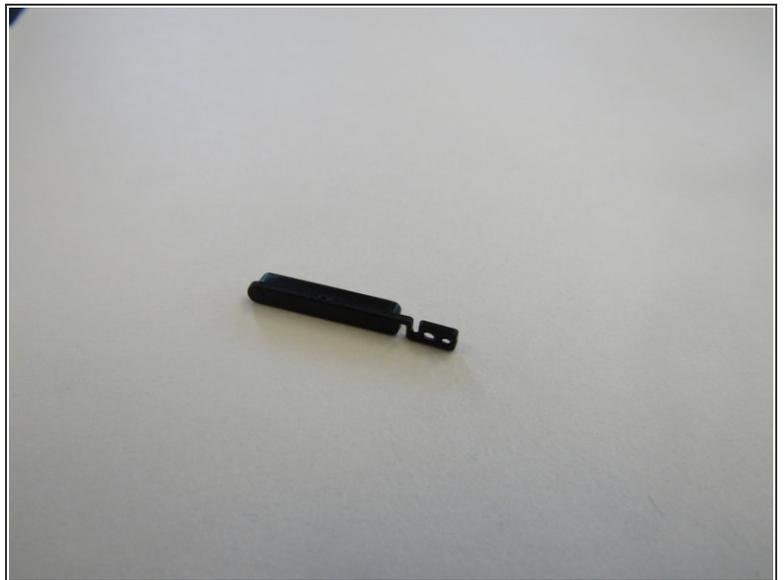
Step 4

- Align and place the new replacement button with positive and negative engravings facing outward into the volume space found in the cover.
