iRobot Roomba 560 Side Sweeper Replacement

Replace the side sweeper so that dirt and lint are guided to your Roomba's vacuum bin.

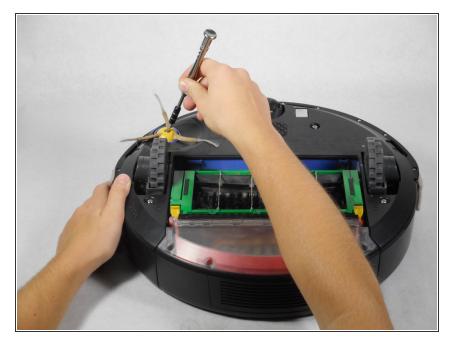
Step 1 — Side Sweeper

- Flip the Roomba upside down.
- Unscrew the single 5 mm screw on the yellow side sweeper using the Phillips #2 driver.

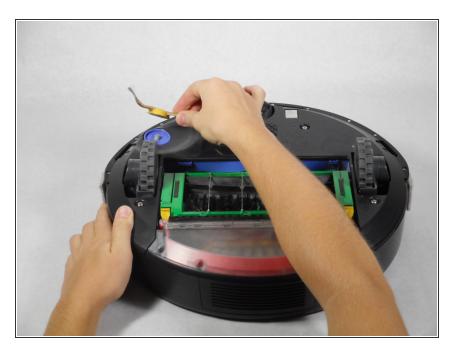
Step 2

Lift the yellow side sweeper, removing it from the device.

To reassemble your device, follow these instructions in reverse order.
