KitchenAid Blender 5KSB52 Ultra Power hard rubber coupling Replacement

Kitchen Aid Hard Rubber Coupling for Mixer 5KSB52 Ultra Power. Replace the overcharged, low-performance coupling.

In this guide, we will show you how to replace an overcharged, low-performance hard-rubber coupling in a Kitchen Aid Mixer 5KSB52 UltraPower.

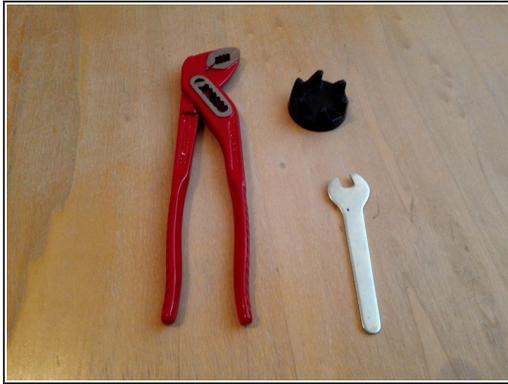
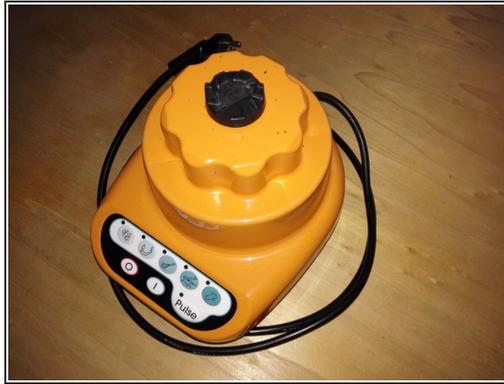
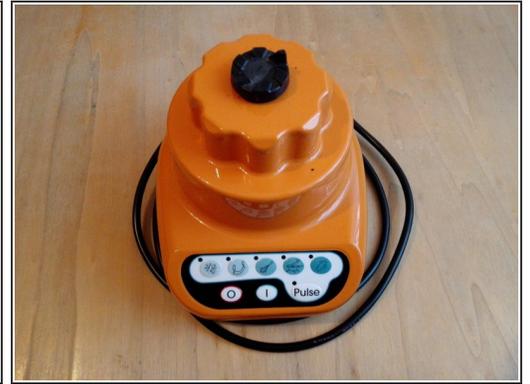
Step 1 — Hard rubber coupling

- Disconnect the blender from the power supply. Prepare tools and spare parts. Tools required: original spanner, small water pump tongs. Spare part: hard rubber coupling

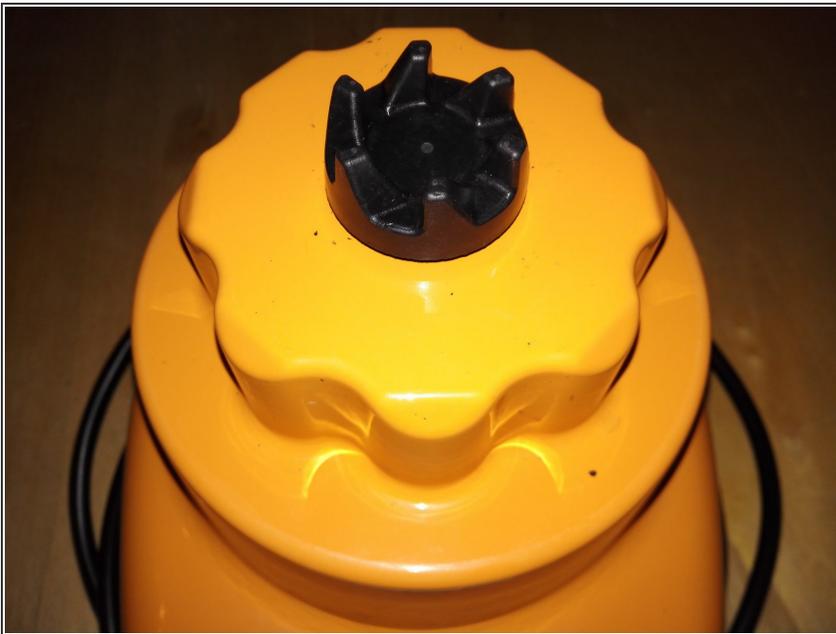
Step 4

- Finished.
