# Monster DNA Wire Replacement

One or both of the speakers on the Monster DNA headphones is not working. The problem could be the wiring on the speaker part.

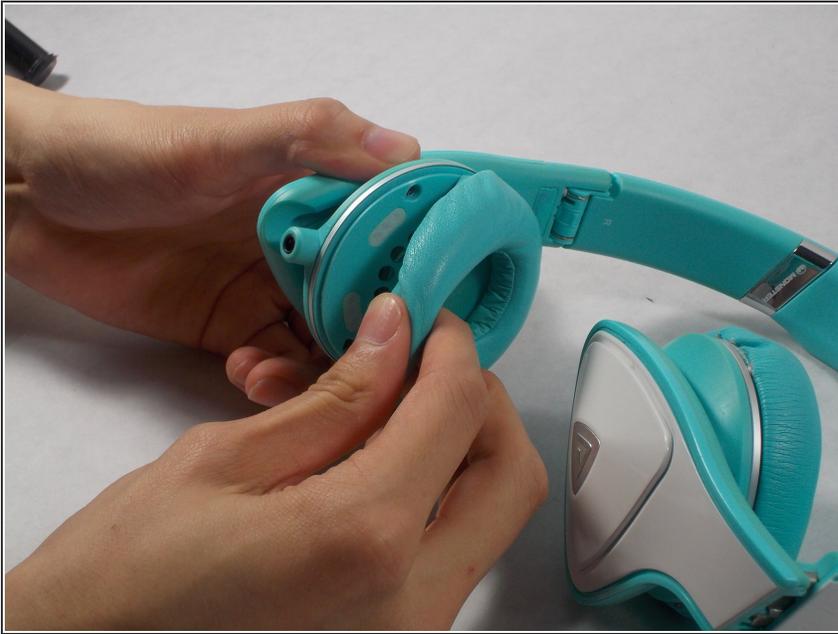
## Step 1 — Wire

- Take off the ear cushions by pulling on the sides.

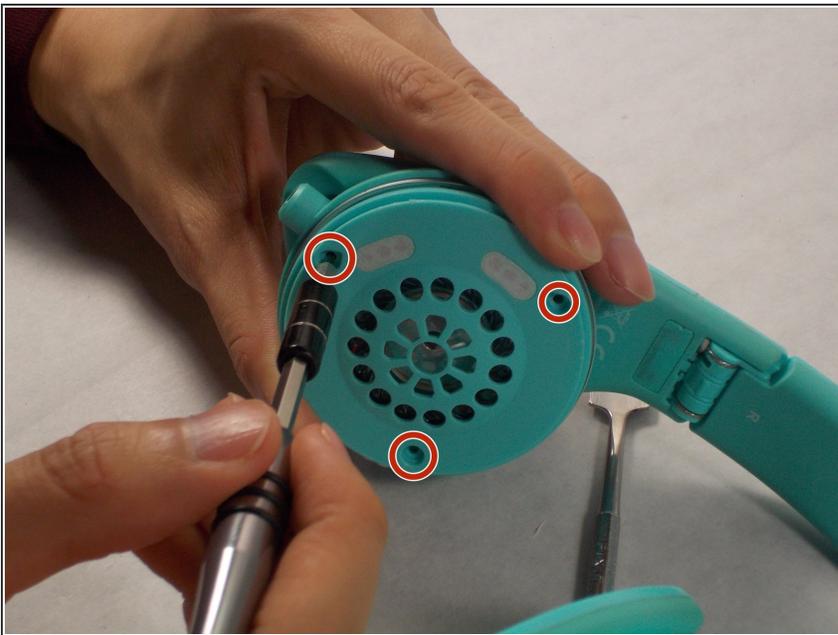
## Step 2

- Use a Phillips #2 screwdriver to unscrew the three 5mm screws that secure the speaker cover.

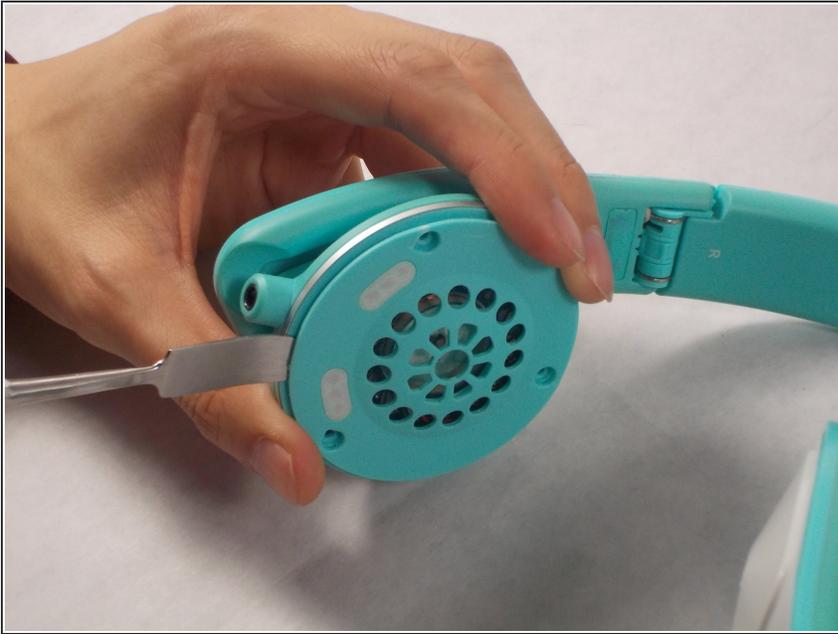
### Step 3

- Use a plastic opening tool or a metal spudger to pry off the plate
- ⚠ Be careful as too much force may cause damage to your headphones.

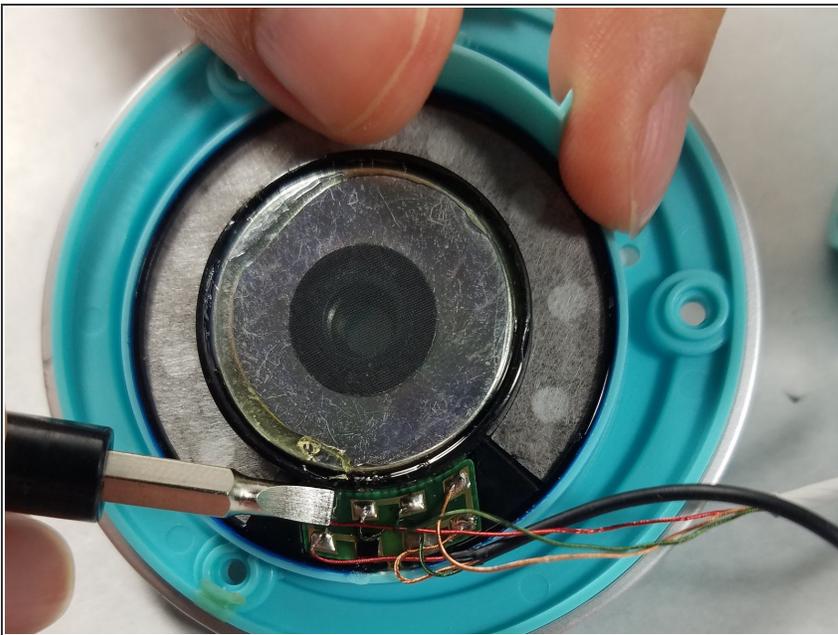
### Step 4

- Once the loose wire or wires are located on the back of the speaker, use a soldering iron to attach the loose wire back onto the speaker.

To reassemble your device, follow these instructions in reverse order.
